TÜRKİYE EMERGENCY ROAD REHABILITATION AND RECONSTRUCTION PROJECT

ENVIRONMENTAL AND SOCIAL DUE DILIGENCE REPORT

CNR-KGM-TERRRP-ESDD-001

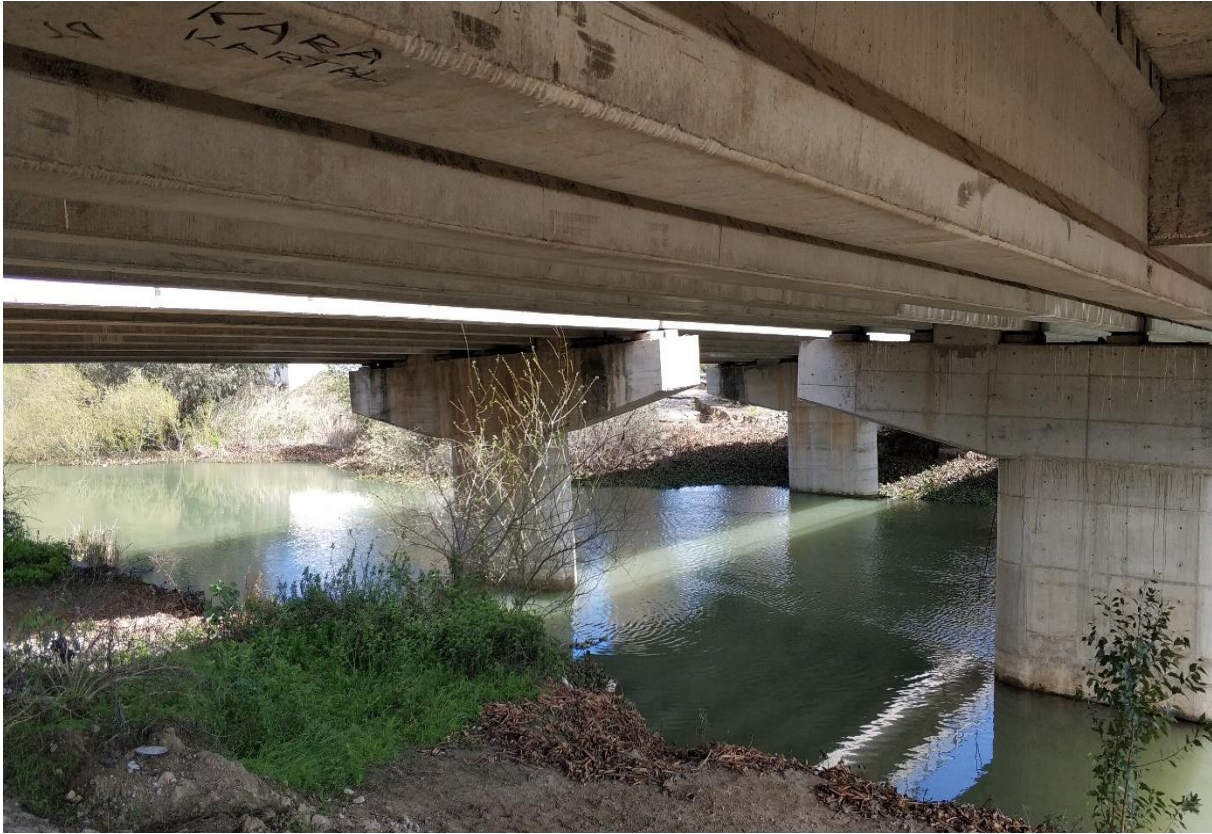
KM:19+981.00 Hittite Bridge (Demirköprü) over the Asi River, located on the Demirköprü-Reyhanlı road within the borders of Hatay province, is a twin bridge with a double platform. The part on the axis left was built in 1989, and the part on the axis right was built in 2010. As a result of the earthquakes that occurred on 06.02.2023, the bridge incurred irreparable damage due to stability losses in its foundations, primarily caused by liquefaction.

Figure 4. Damage on the Bridge Piers

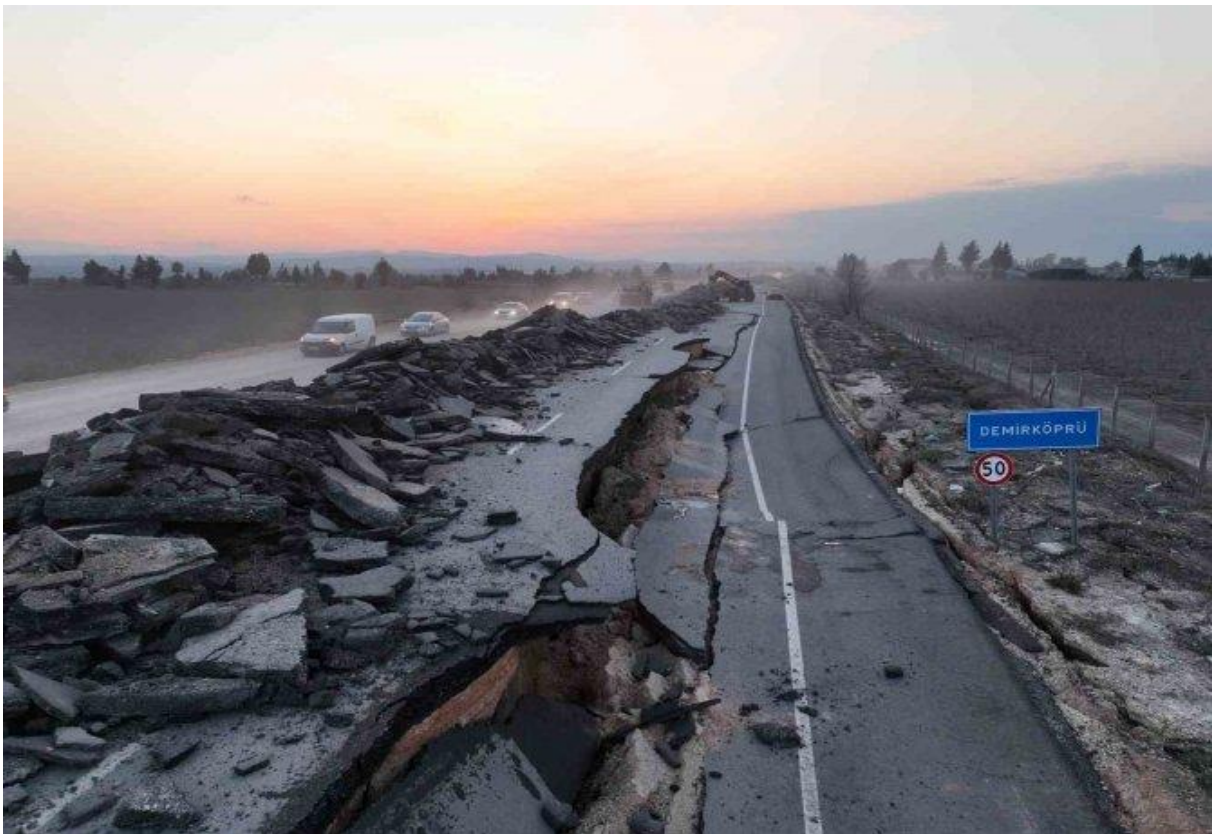
It was observed during the site visit that Demirköprü Bridge is currently being reconstructed.

Figure 5. View of the Demirköprü Bridge After the Earthquake

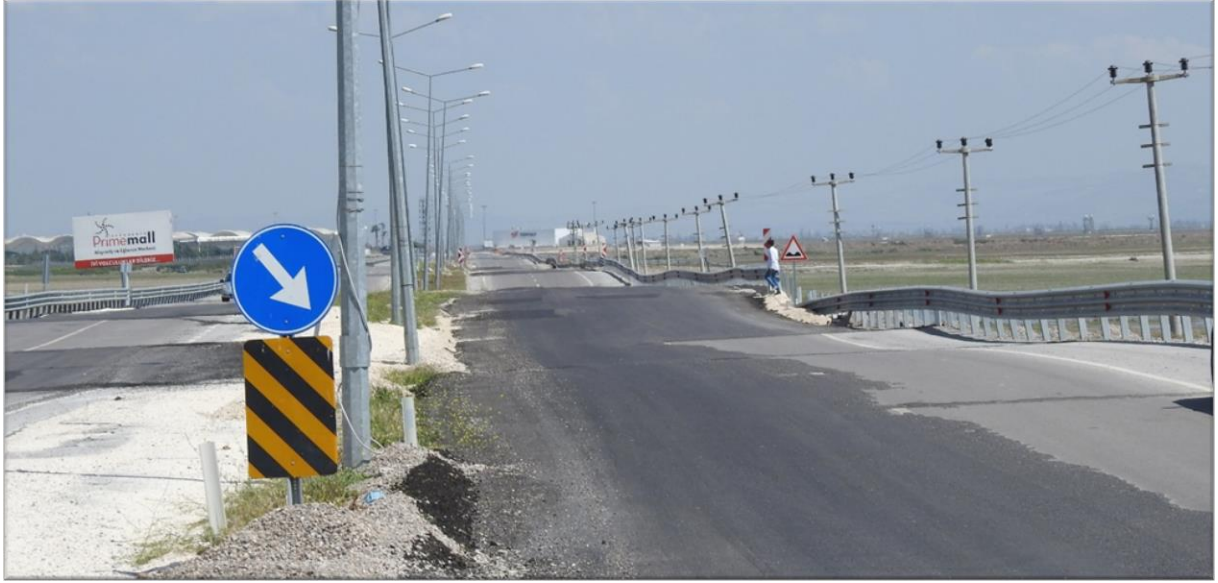
Deformations that disrupted the road embankment and retaining wall structures were detected in three different locations along the route. It was determined that these deformations occurred as a result of secondary ruptures due to the main fault system and the resulting ground liquefaction problem.

Figure 7. View of the Hatay Airport Road After the Earthquake (Km:2+840-3+480)

It was stated by the contractor that sub-project's construction works started in October 2023 and planned to be completed in May 2024. It was observed during the site visit that the construction works are progressing rapidly. Soil reinforcement is carried out by pumping a mixture of cement and water to a depth of 20 meters with Deep Soil Mixing (DSM) machines.

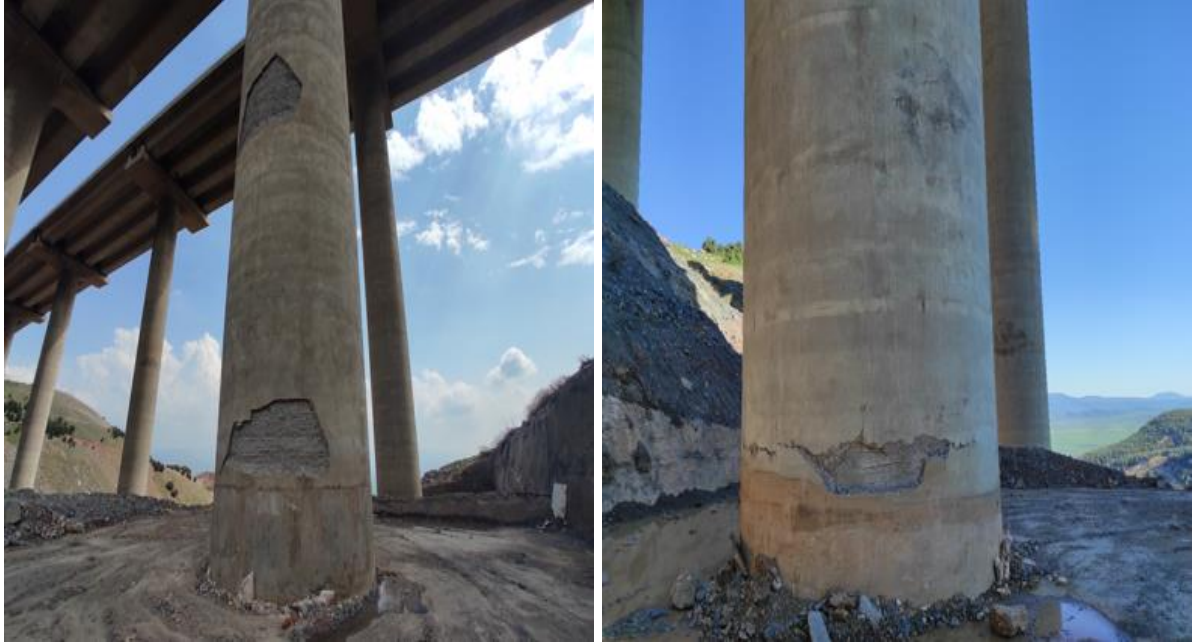
Due to the earthquakes that occurred on 06.02.2023, damages occurred in the expansion joints, floor concretes, approach fillings, earthquake wedges, supports and elevations of five (5) viaducts; Şehitler, Nurdağı, Atatürk, Turgut Özal and Bağcınar Viaducts (see Figure 9).

Figure 10. Damages on the Piers – Şehitler Viaduct

Within the scope of the sub-project, it is planned to carry out superstructure repair works along the project route, including bridge auxiliary elements, supports and expansion joints. Additionally, reinforcement works are planned for the columns of the Şehitler, Nurdağı, and Başpınar Viaducts (see Figure 10, Figure 11 and Figure 12 respectively) using steel armor and carbon fiber polymer.

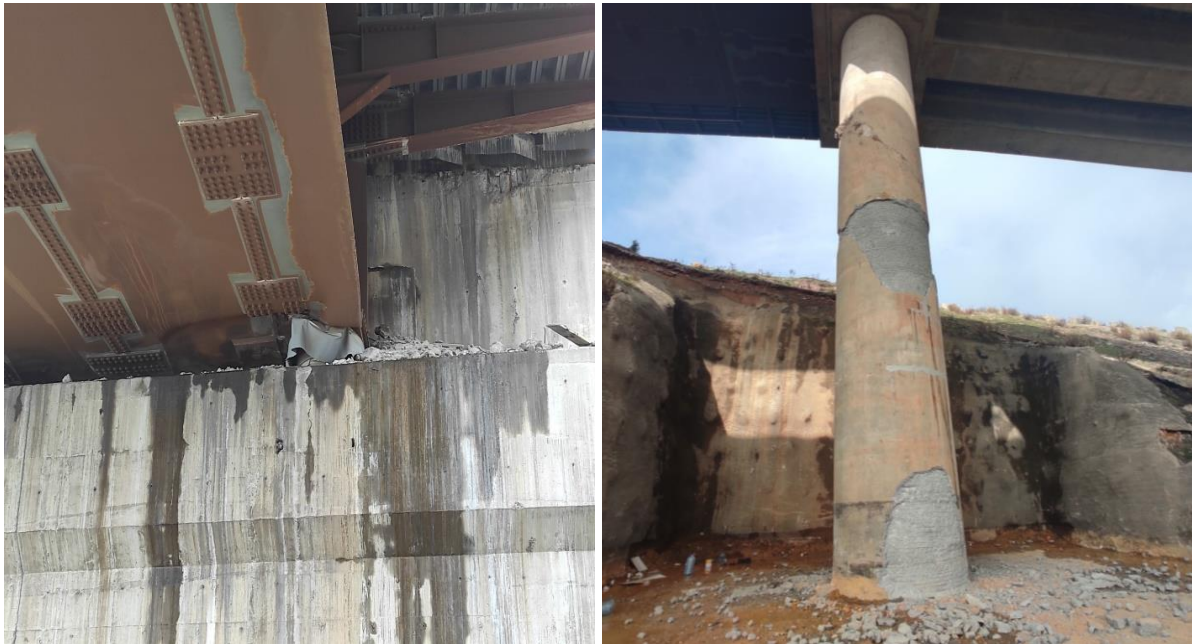
Figure 11. Damages on the Nurdağı Viaduct

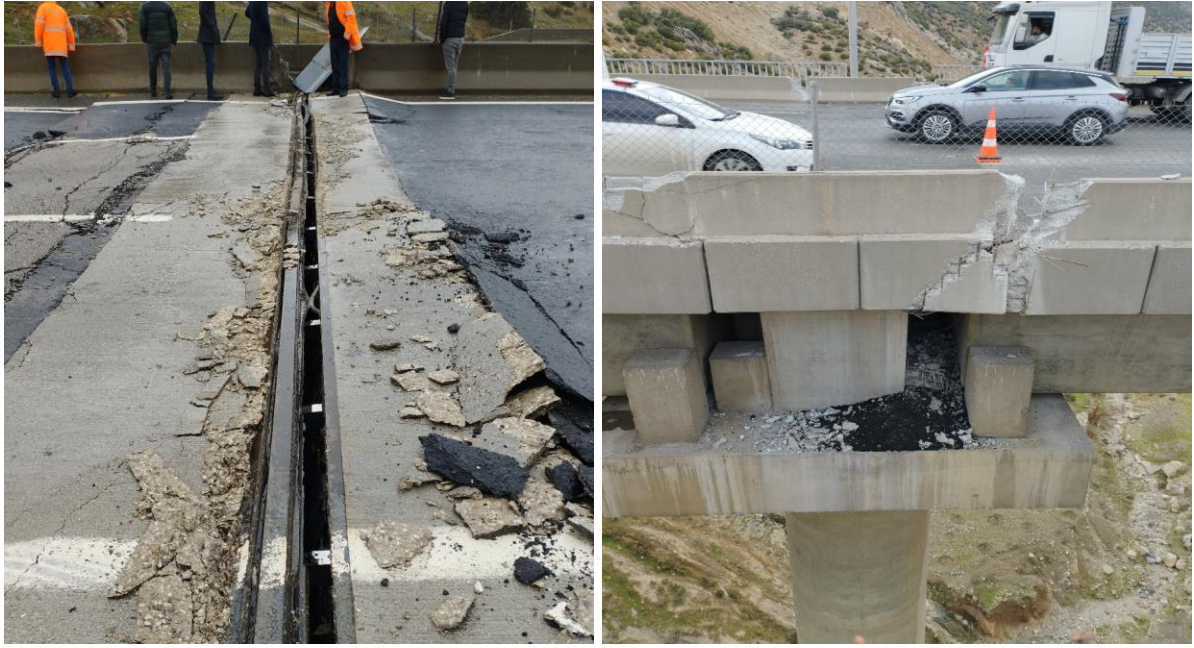
Figure 12. Damages on the Başpınar Viaduct

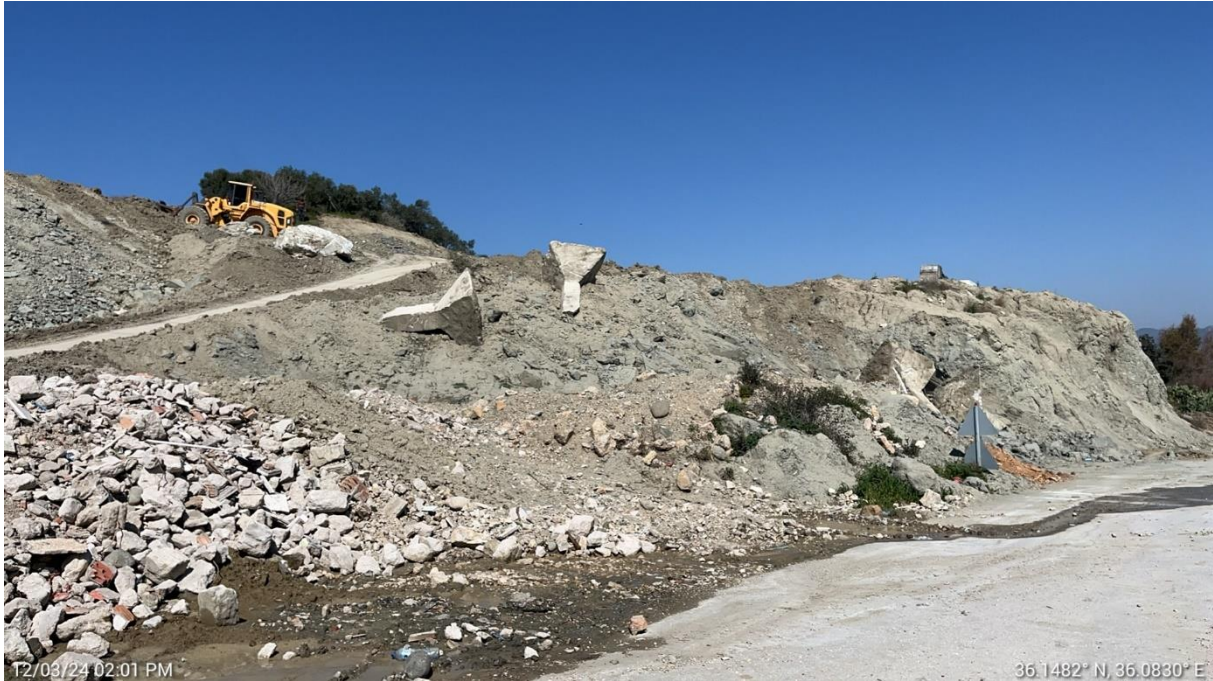
Bored pile wall construction in various segments and superstructure renovation works along the 27 km road are carried out in order to prevent the risk of landslides caused by steep slopes. Additionally, a bridge will be rebuilt as part of the work. It was observed during the site visits that the landslide removal works at the 6th km are continuing by the subcontractor.

Figure 14. Landslide Removal Works

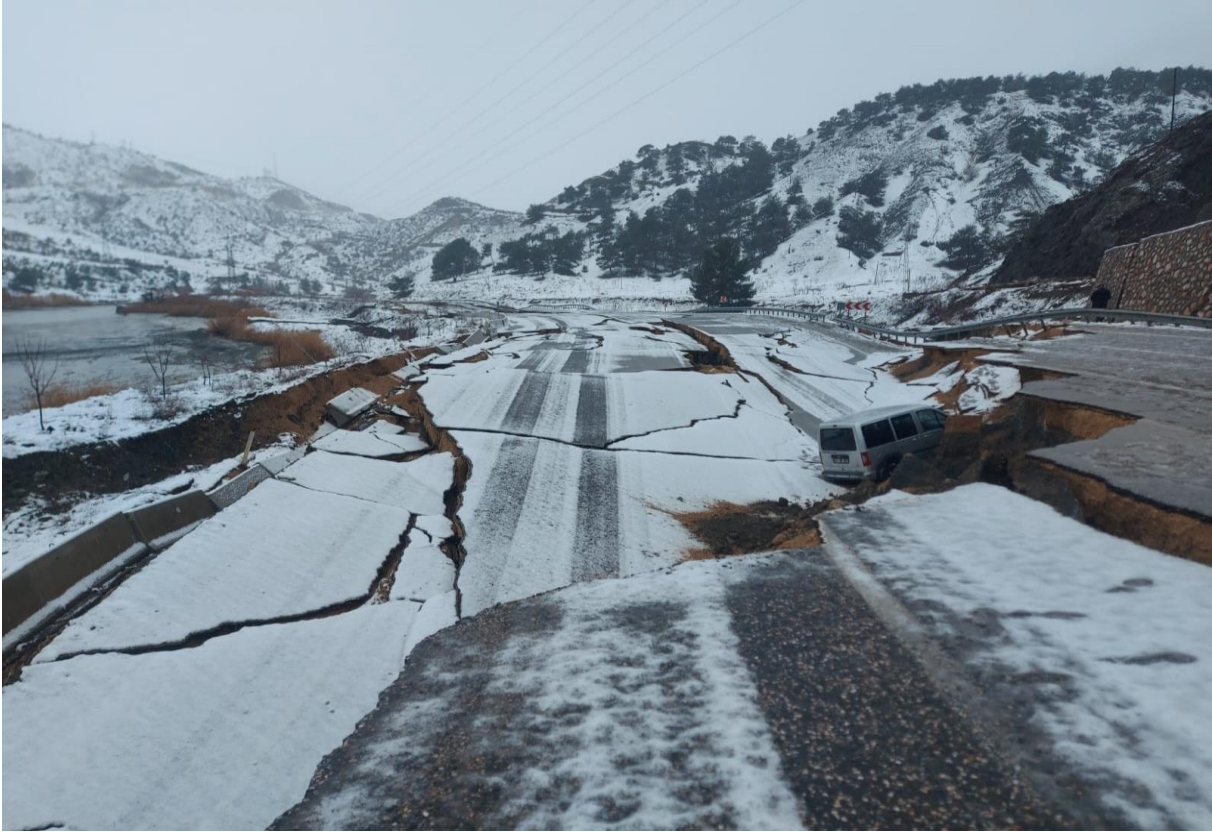
The damages occurred at the sub-project area due to the earthquakes on 06.02.2023 can be listed as; transformer zone landslides (see Figure 17), Erkenek Tunnel entrance portal area (see Figure 18), Erkenek Tunnel internal lining structure, deformations occurring in fillings, and damages occurred in Erkenek Tunnel electromechanical systems. The extension of the Erkenek Tunnel's entrance portal (see Figure 19) by 48 meters is also planned within the scope of the sub-project.

Figure 17. Damage on the Transformers Zone (Malatya-Gölbasi Road KM:89+260-KM:30+100)

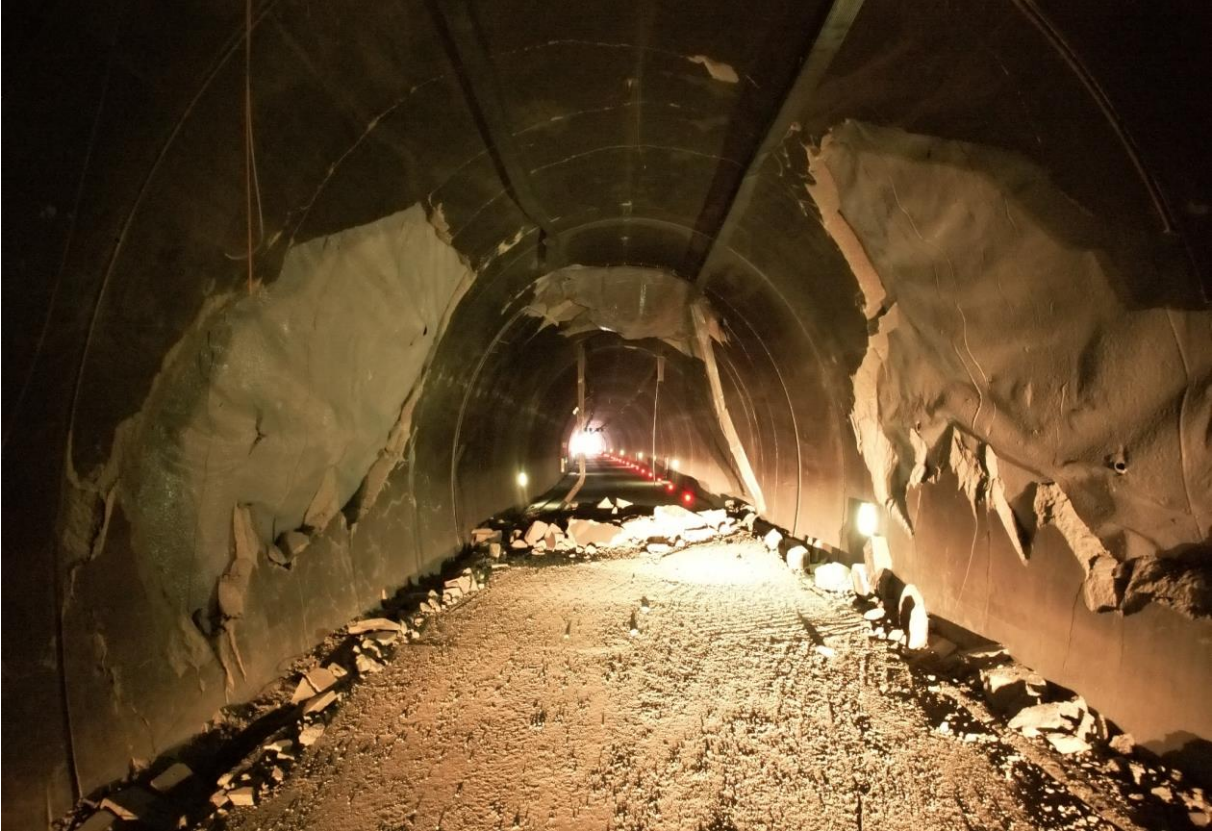
Figure 18. Damage on Erkenek Tunnel Entrance Portal Area

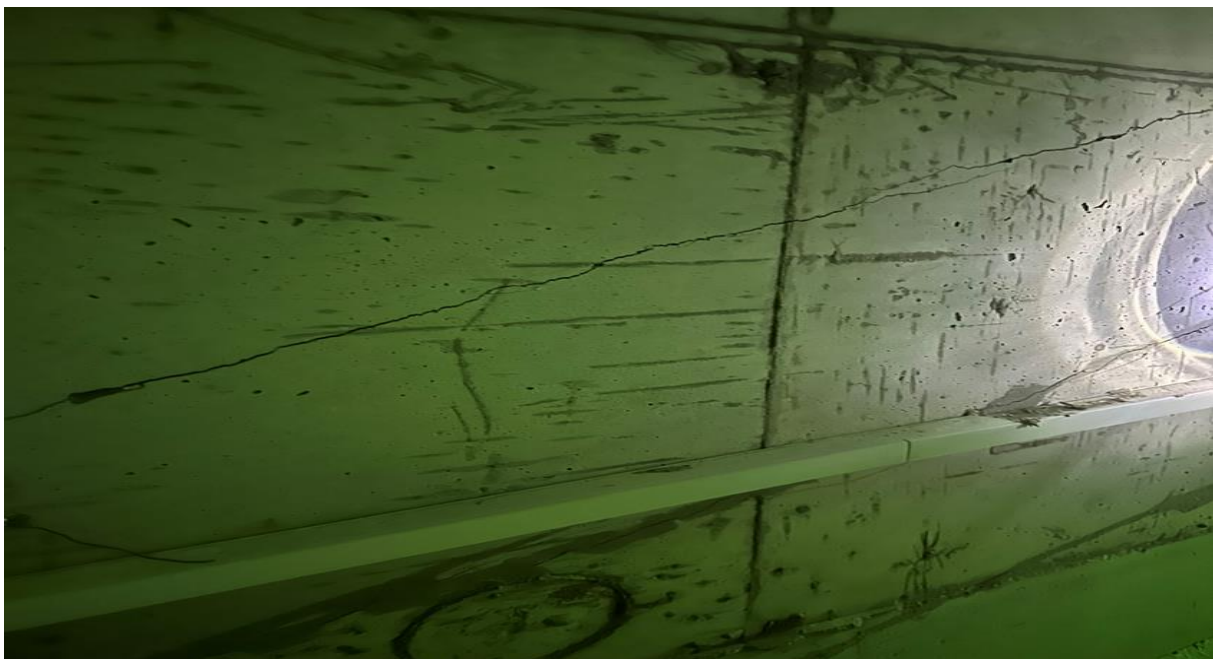
Numerous hairline shear cracks (see Figure 22) were identified at the edge openings of the bridge, particularly in the anchorage areas. Additionally, the teflon coatings on the 4 bearings (see Figure) on both sides has worn off and requires replacement.

Figure 22. Hairline Shear Cracks

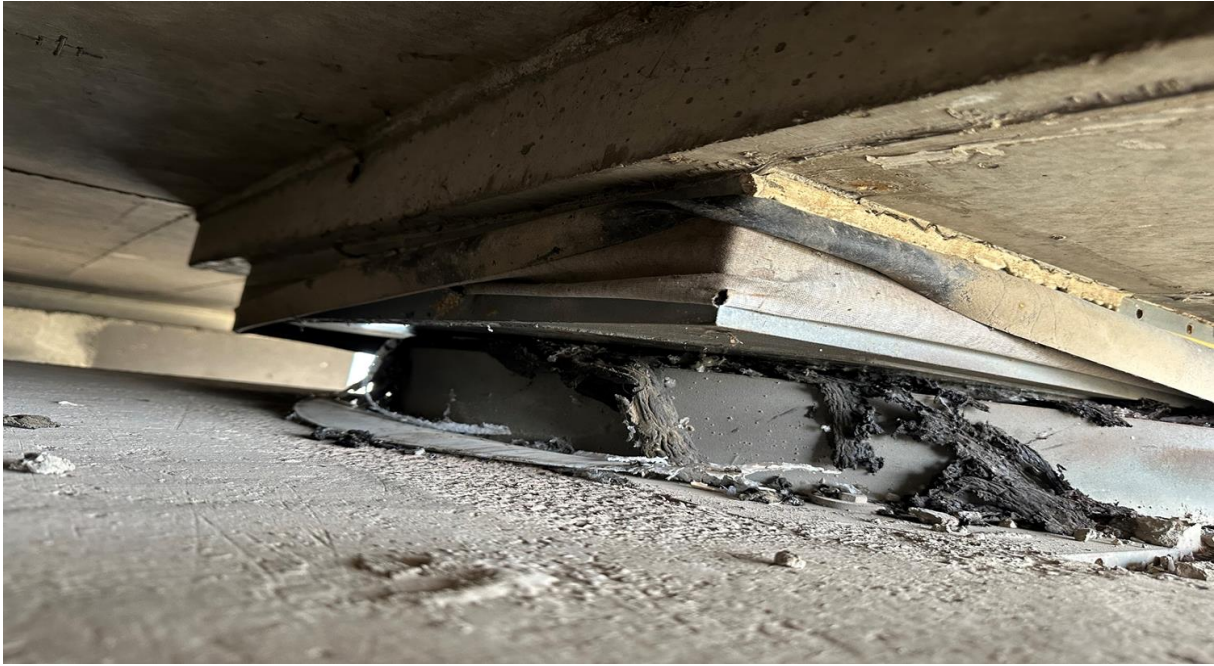
Figure 23. Damages on the Structural Bearings

Scope of the sub-project: Replacement of the structural bearings and expansion joints
The sub-project location map is given in Figure 20.

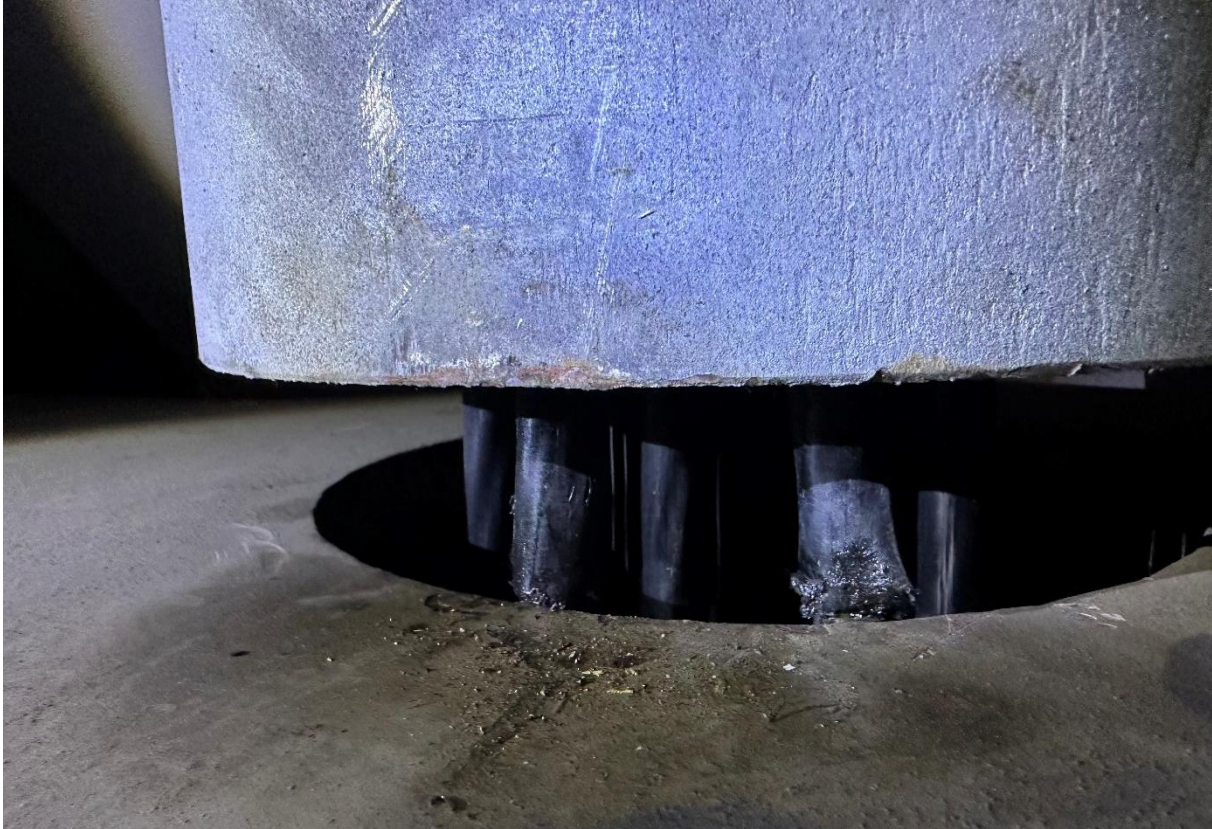
Figure 28. Damaged Suspension Cables

Dismantling of cable suspension ropes, anchor covers, injection dismantling of the rope bundle, nail checks and inspection, anchor covers, injection, installation of anchor covers and re-injection, disassembly and supply of damaged inclined suspension cable system and re-assembly and anchoring of the cable system works will also be conducted.

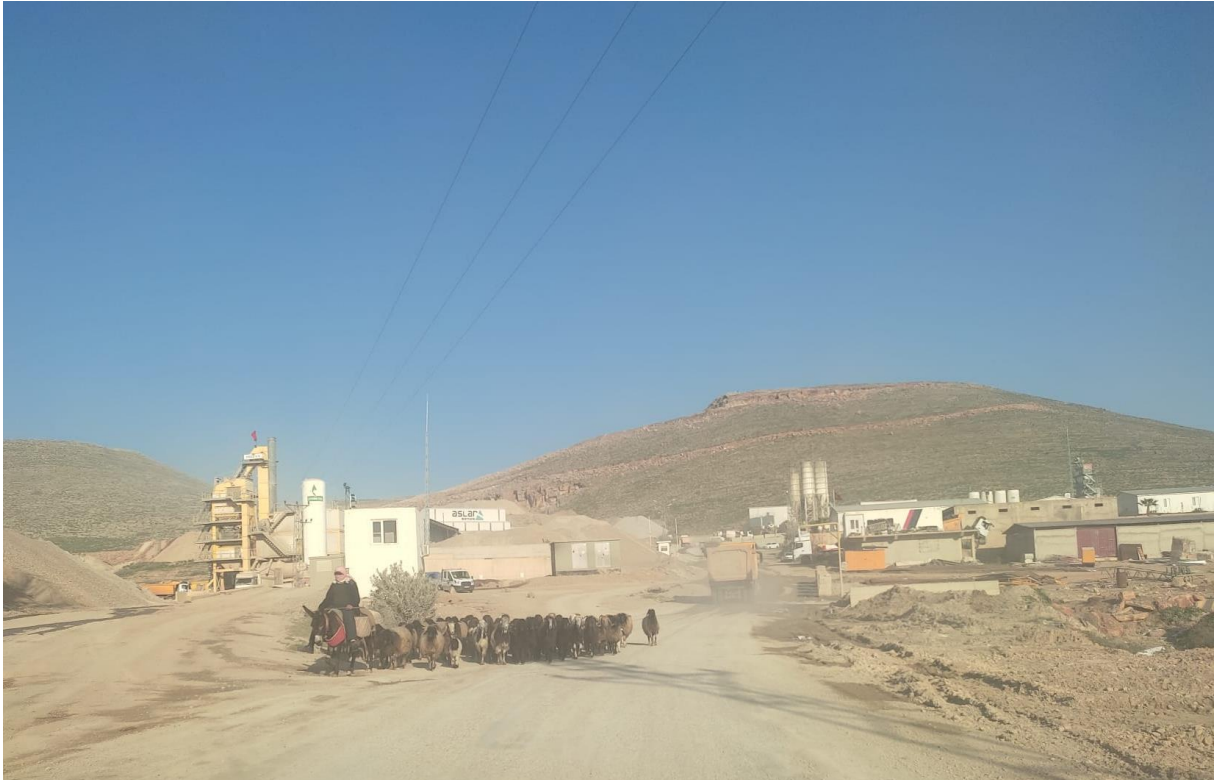
It was observed that, some shepherds are using the access roads of the Construction Site with their animals. Therefore, on the access roads of the Kuruyer Construction Site, due to the heavy vehicle traffic, traffic accident risk may increase and local people who are engaged in the husbandry activities may be adversely impacted.

Figure 32. Shepherd with animals

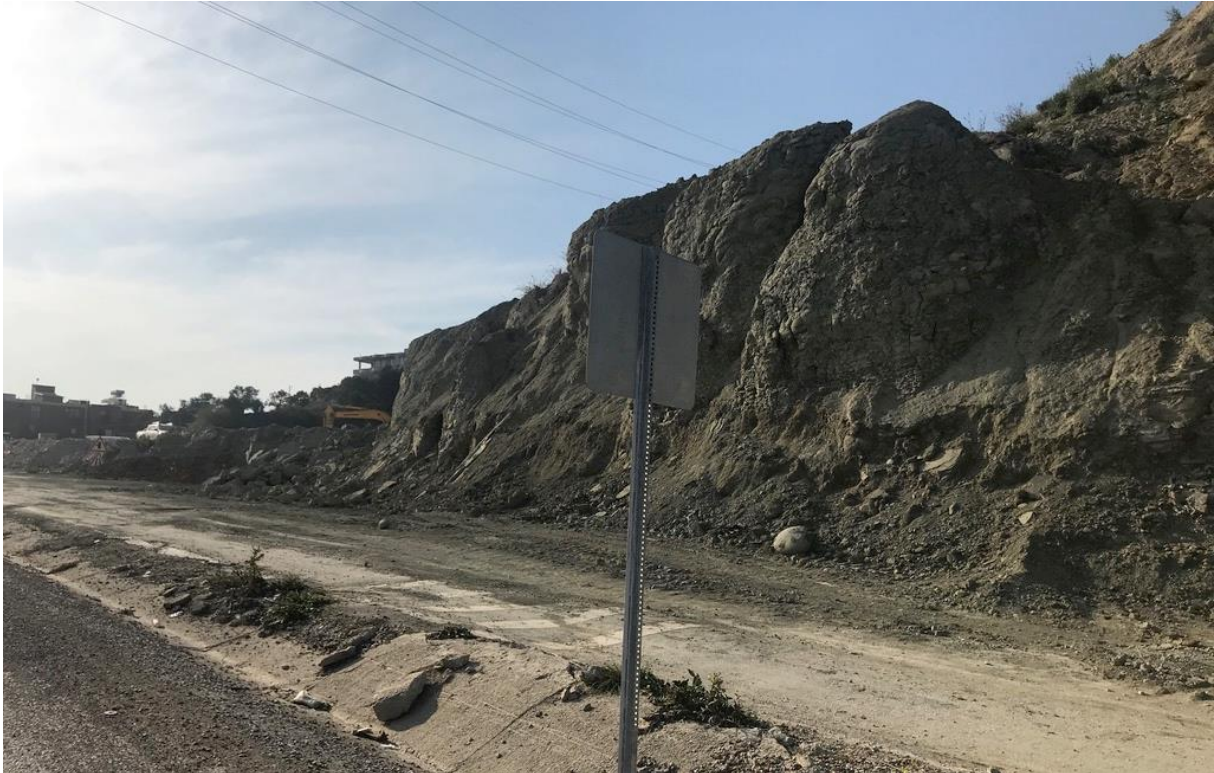
Also, a landslide has damaged the road in Küçükkaracaay District as shown in Figure 61 below and restoration works have been started. Container camping areas are available in various locations throughout the region.

Figure 61. Landslide in Küçükkaracaay District Road

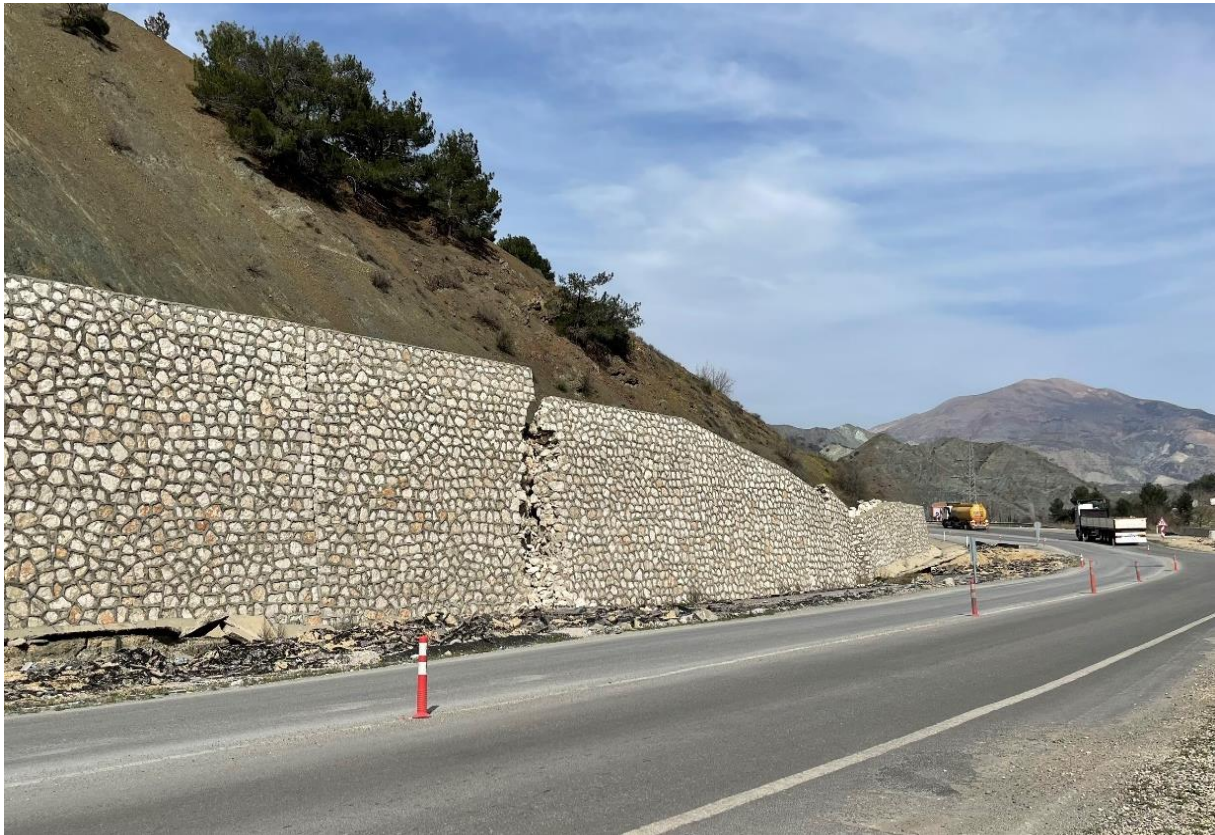
- It was stated by 8th Regional Directorate of Highways that the damages on the road were temporarily repaired after the earthquake.

Figure 96. Damage on the Road - 1

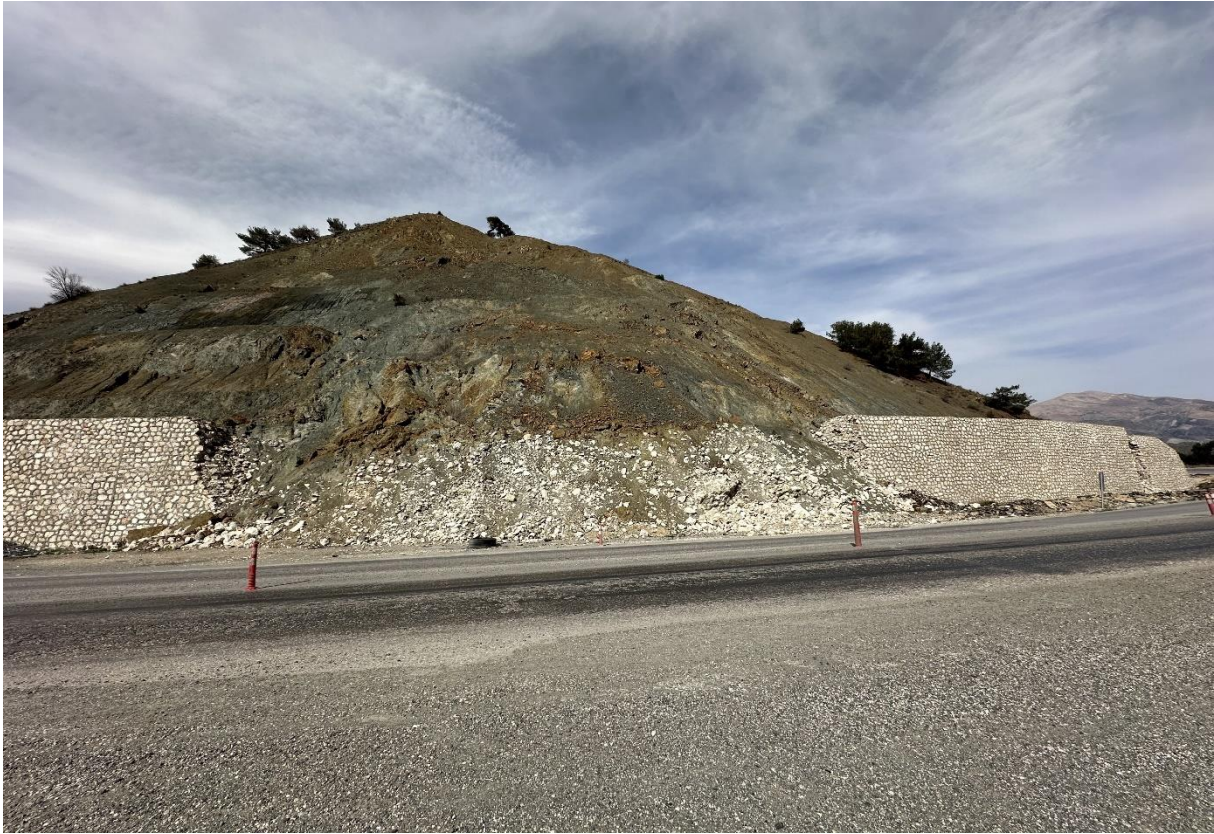
Figure 97. Damage on the Road – 2

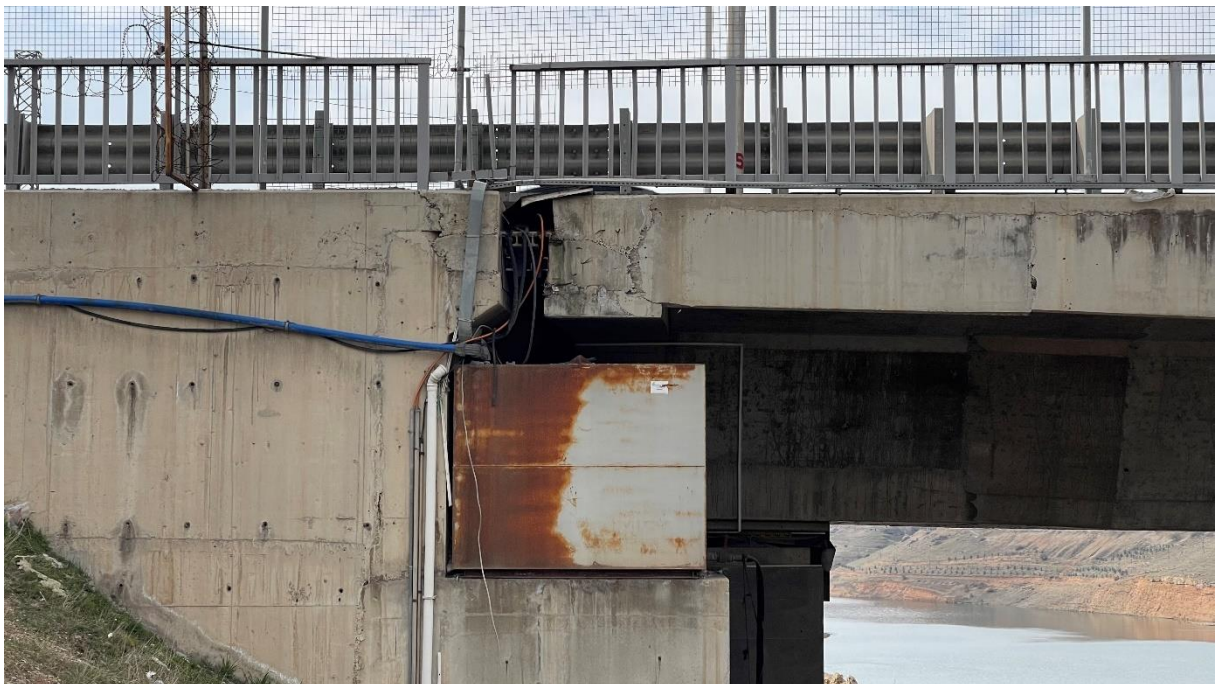
Figure 103. Damages on the Bridge
