Izmir Metro Project Phase 4

Fahrettin Altay – Narlıdere Kaymakamlık Line

Environmental and Social Review Report

26 August, 2020

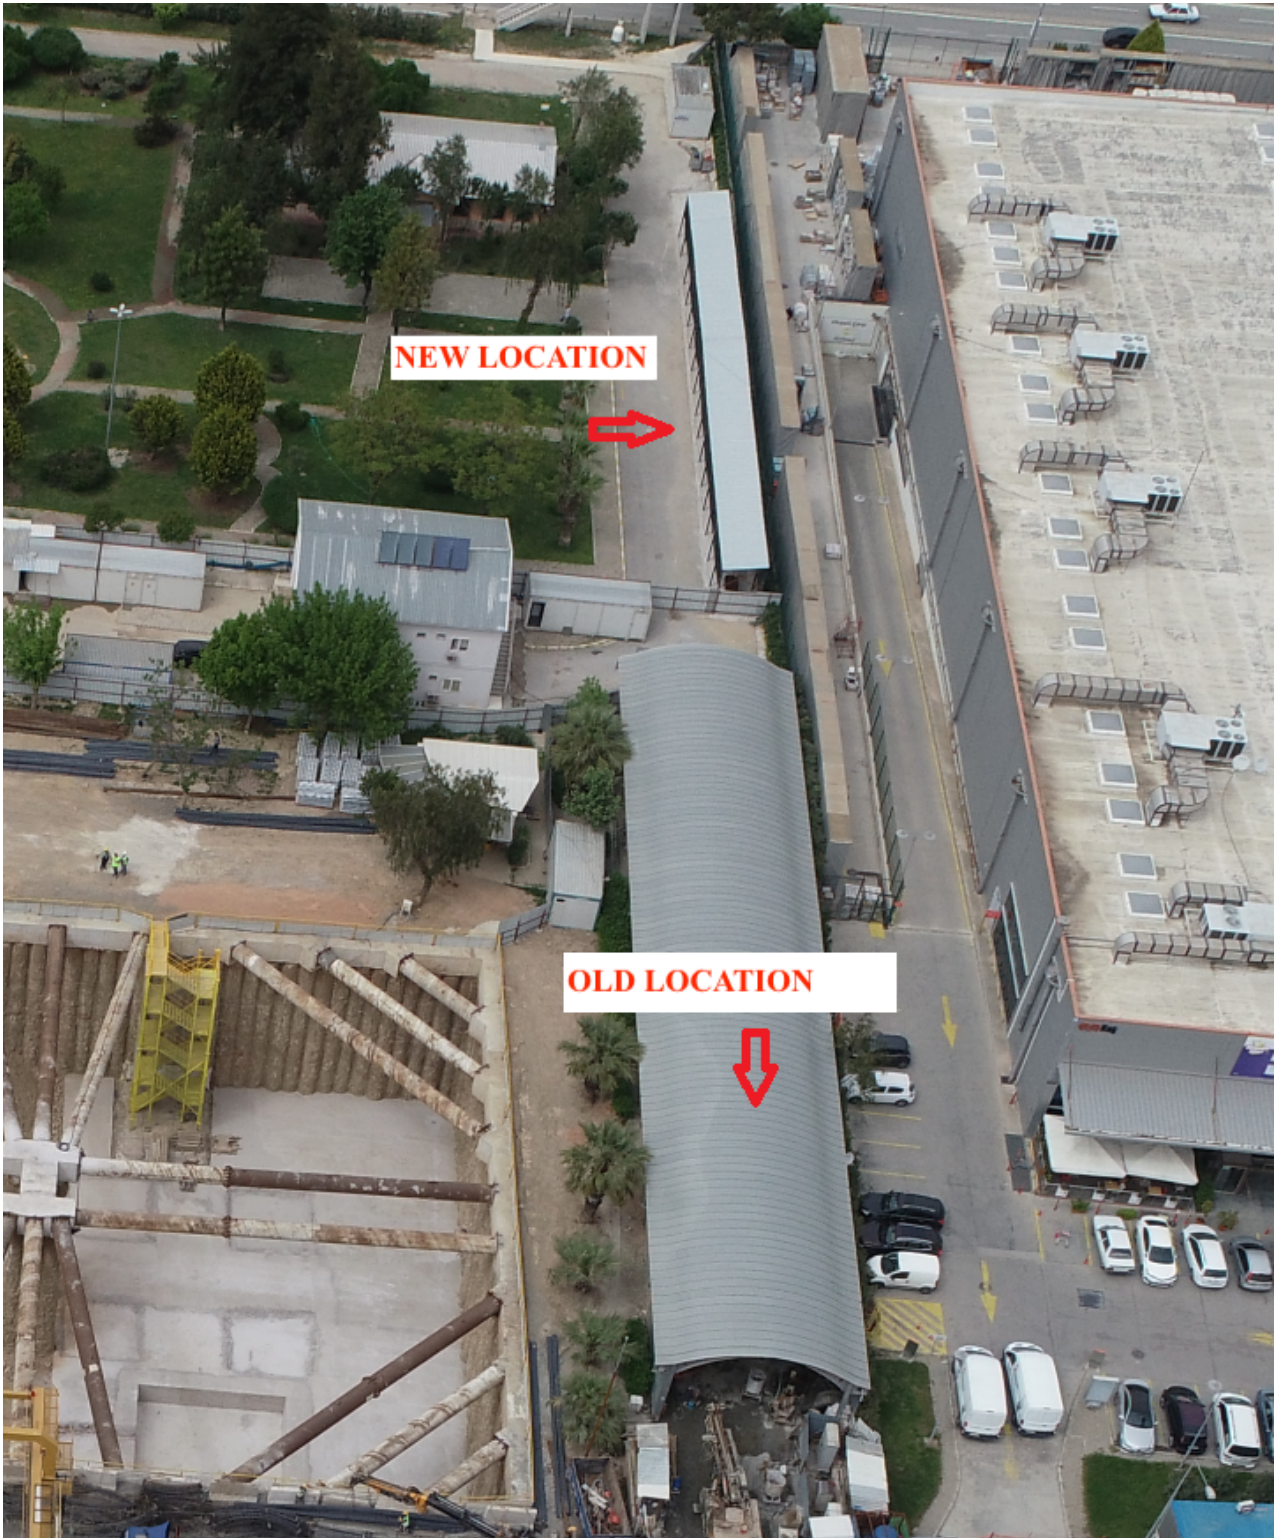
Annex D The Organic Products Marketplace Old/New Locations

NEW LOCATION
