TÜRKİYE EMERGENCY ROAD REHABILITATION AND RECONSTRUCTION PROJECT

ENVIRONMENTAL AND SOCIAL DUE DILIGENCE REPORT

CNR-KGM-TERRRP-ESDD-001

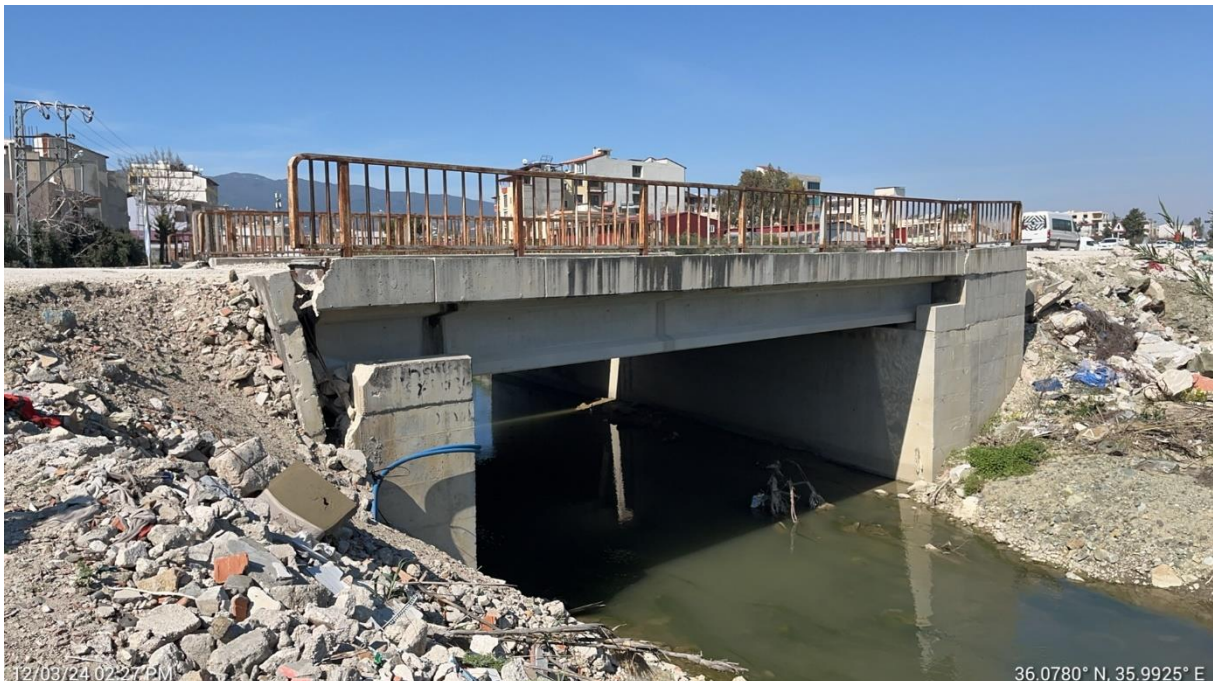
Scope of the sub-project: Repairing the breaks and deformations that occurred on the Antakya-Samandağ Road, as well as asphalt renewal works, will be carried out between KM:0+000 – 26+850. Additionally, reclamation works for landslide control and the reconstruction of a bridge located in Sutaşı Neighborhood are also planned.

Figure 15. Bridge to be Reconstructed

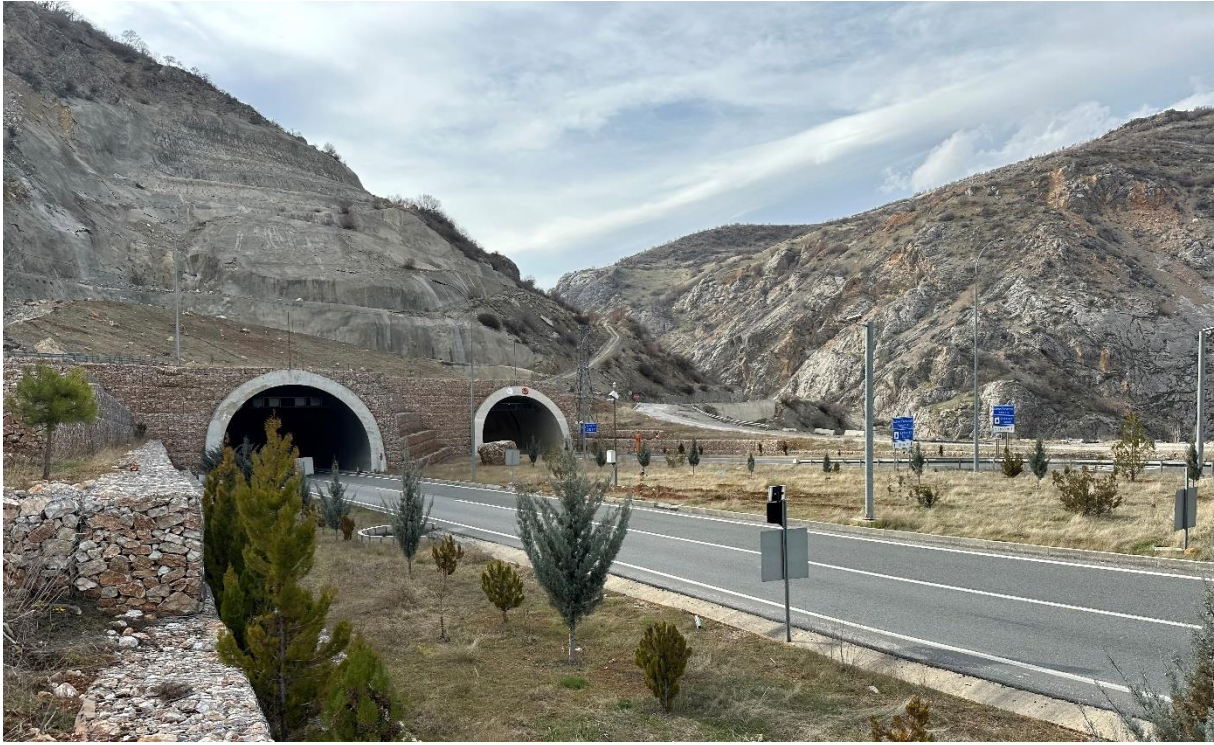
The damages occurred at the sub-project area due to the earthquakes on 06.02.2023 can be listed as; transformer zone landslides (see Figure 17), Erkenek Tunnel entrance portal area (see Figure 18), Erkenek Tunnel internal lining structure, deformations occurring in fillings, and damages occurred in Erkenek Tunnel electromechanical systems. The extension of the Erkenek Tunnel's entrance portal (see Figure 19) by 48 meters is also planned within the scope of the sub-project.

Figure 19. Erkenek Tunnel – Entrance Portal

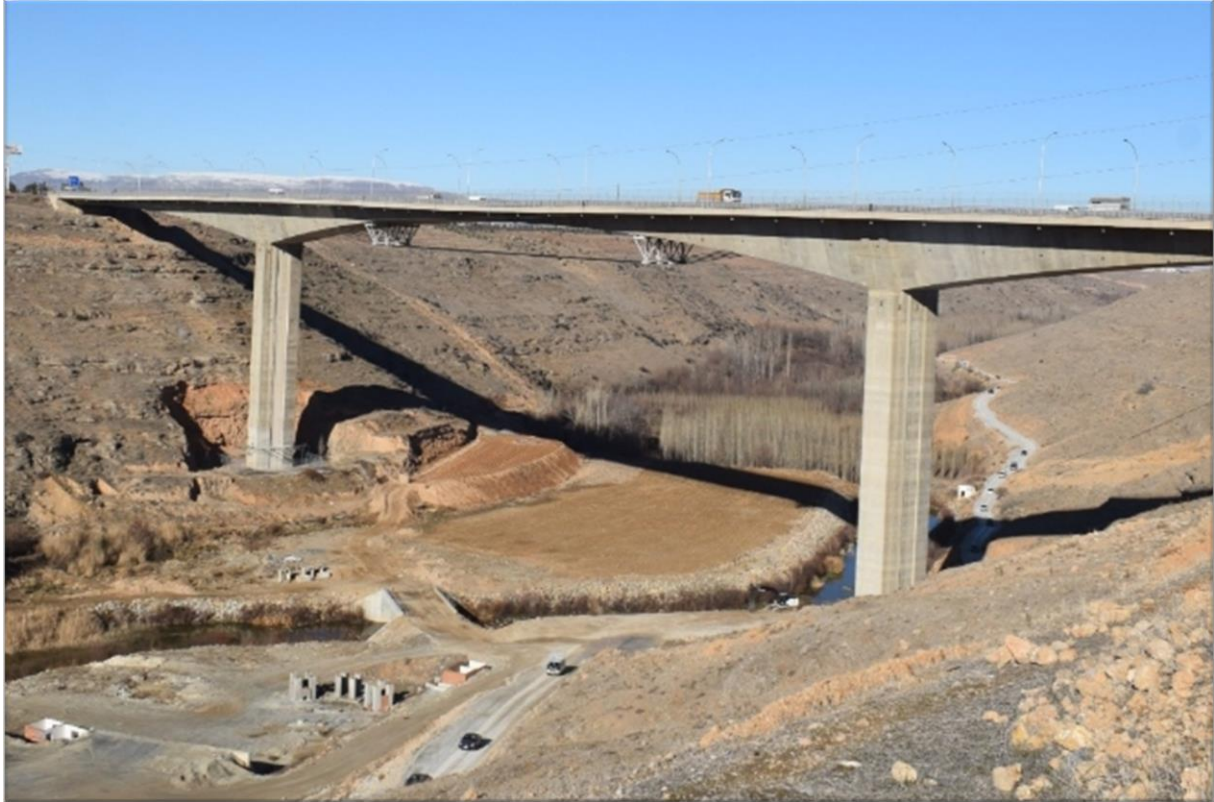
Numerous hairline shear cracks (see Figure 22) were identified at the edge openings of the bridge, particularly in the anchorage areas. Additionally, the teflon coatings on the 4 bearings (see Figure) on both sides has worn off and requires replacement.

Figure 21. Beylerderesi Bridge

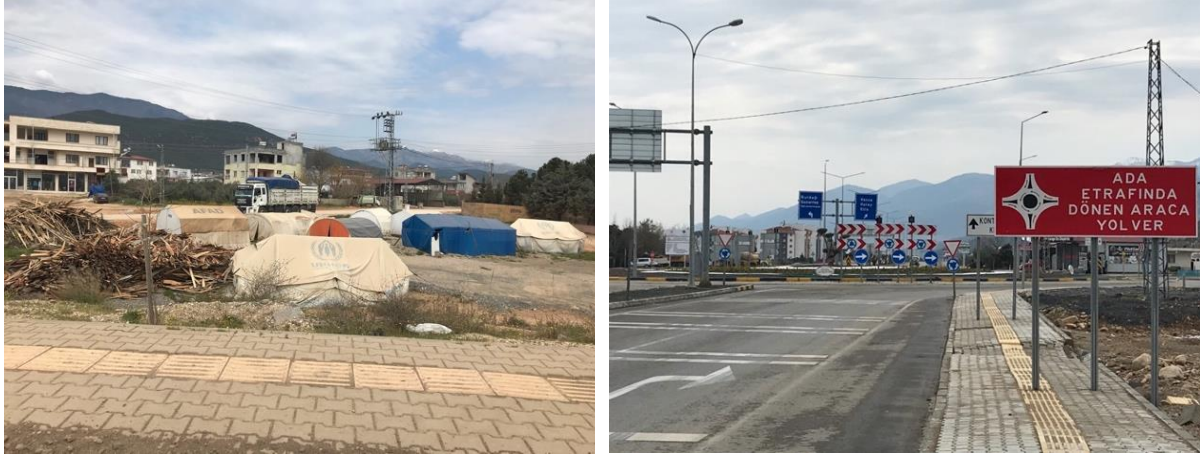
Traffic Impacts: İslahiye-Hassa-Kırıkhan Road (see Figure 31) is approximately 80 km line passing through residential areas. Therefore, sub-project should be managed and monitored with the traffic safety measures and trainings to be provided to the workers, drivers. Especially for the sensitive points such as schools, container camps, hospitals etc. along the route will be considered and related stakeholders should be informed on the health and safety measures, construction schedule and road restrictions, if occurred.

Figure 31. Islahiye-Hassa-Kırıkhan Road

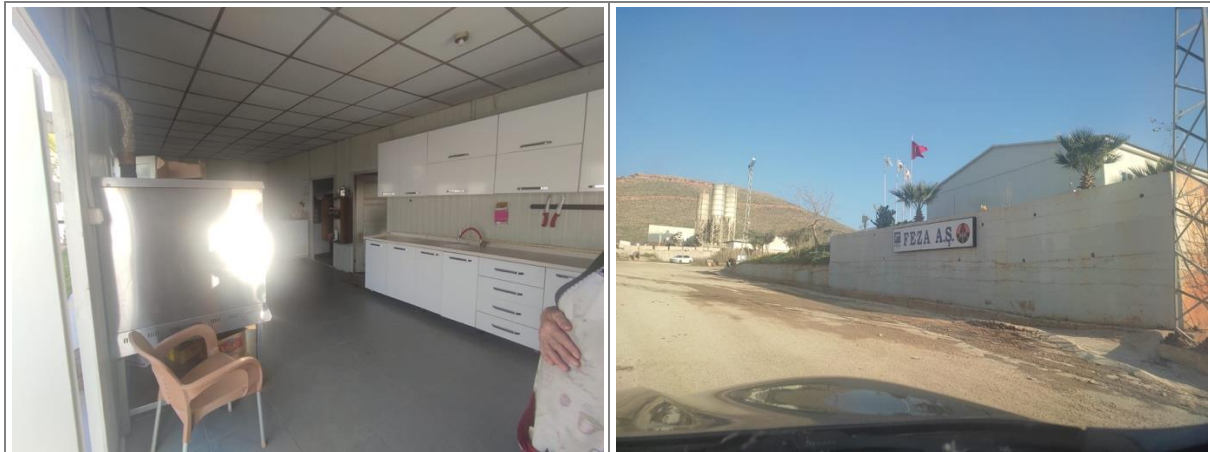
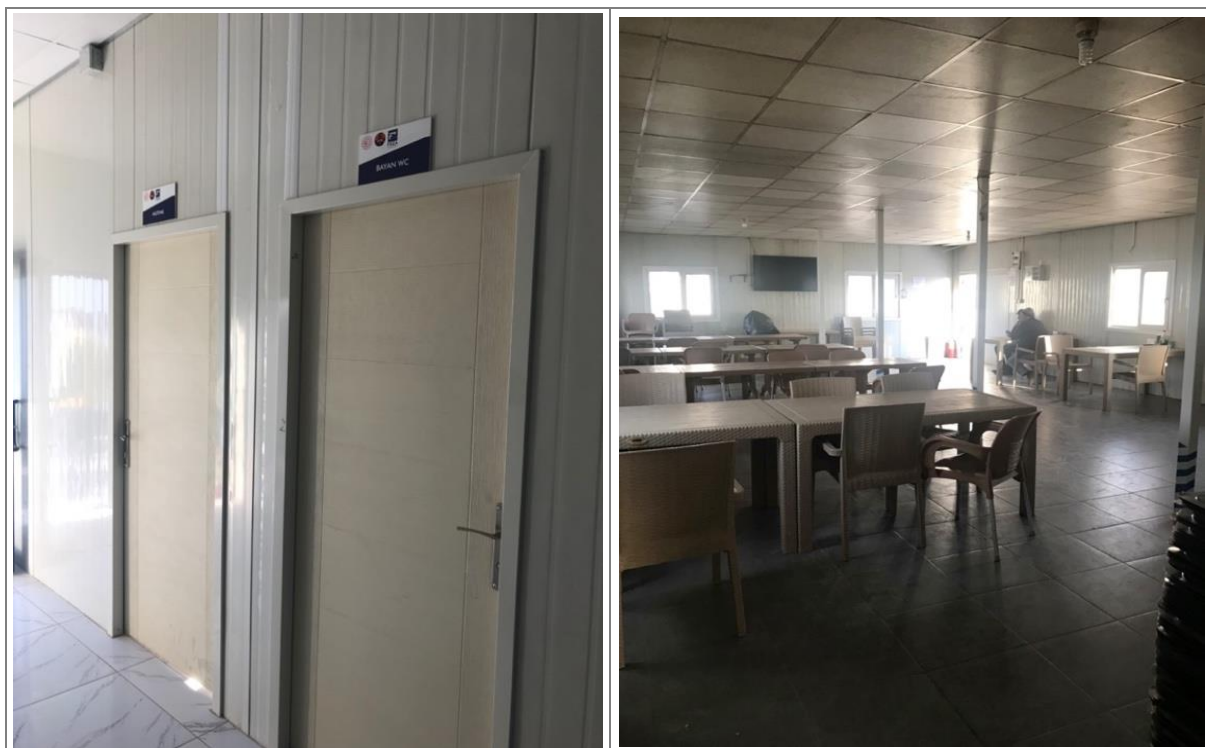
Figure 33. Construction Camp Site Views

It was observed that the construction site area has not been fenced off, and there is no security. This situation may create security issues for both outside visitors and workers.

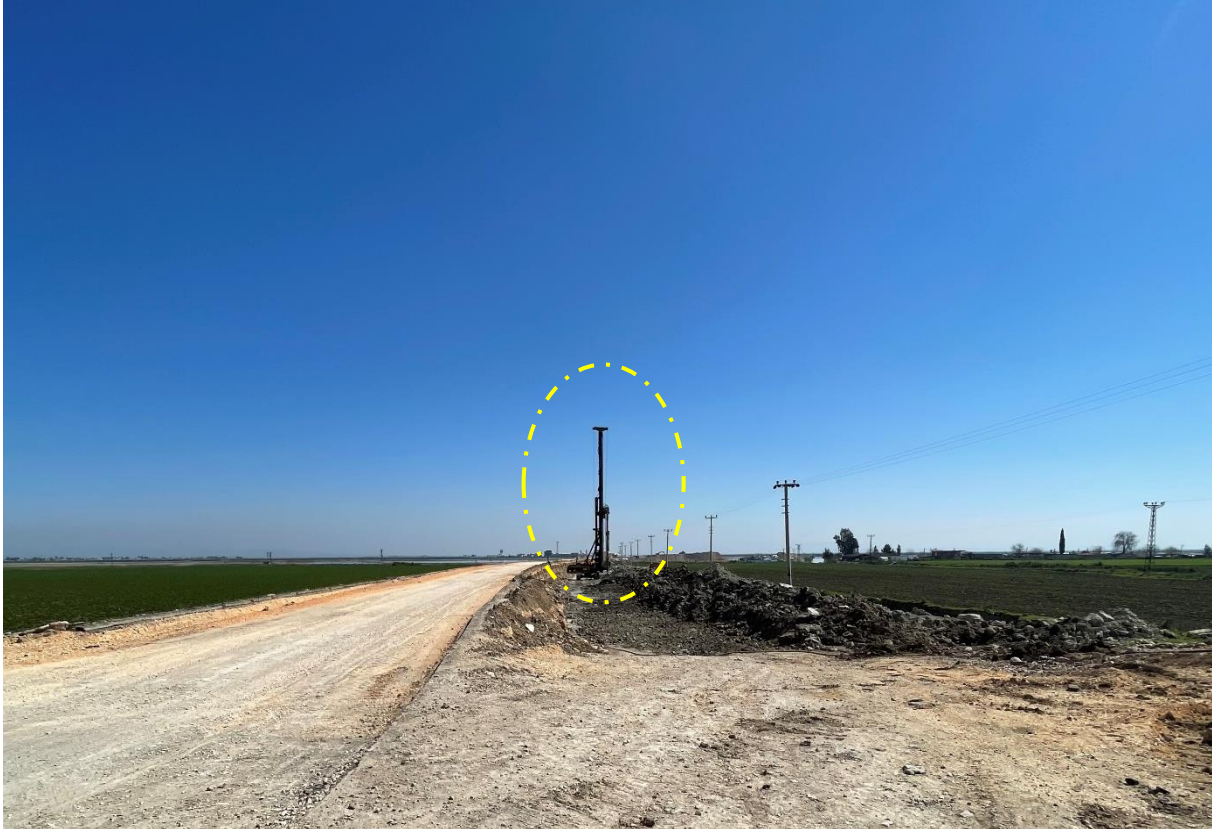
- Maintenance works are conducted – oil spills were observed. There are no spill kits.
- Meals are coming from Kızılkaya Construction Site. No cooking on-site.

Figure 35. Deep Soil Mix (DSM) Machines on-site

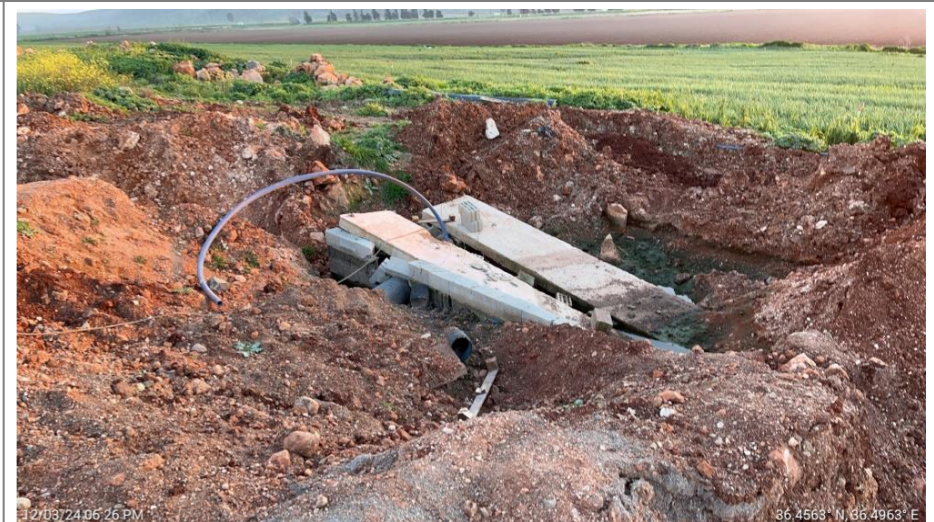
Wastewater management	Wastewater infrastructure works are continuing, the old septic tank is being demolished (see Figure 41) and the new septic system is about to be completed (see Figure 42). Service has been received from Kırıkhan Municipality in the previous periods.	The facilities at the Kızılkaya construction and accommodation site have been utilized.	Construction activities have not started yet.	There was no wastewater infrastructure in the construction area, it was stated that the opportunities of nearby facilities have been used.

Figure 41. Old Septic Tank in the Kizilkaya Construction and Accommodation Site

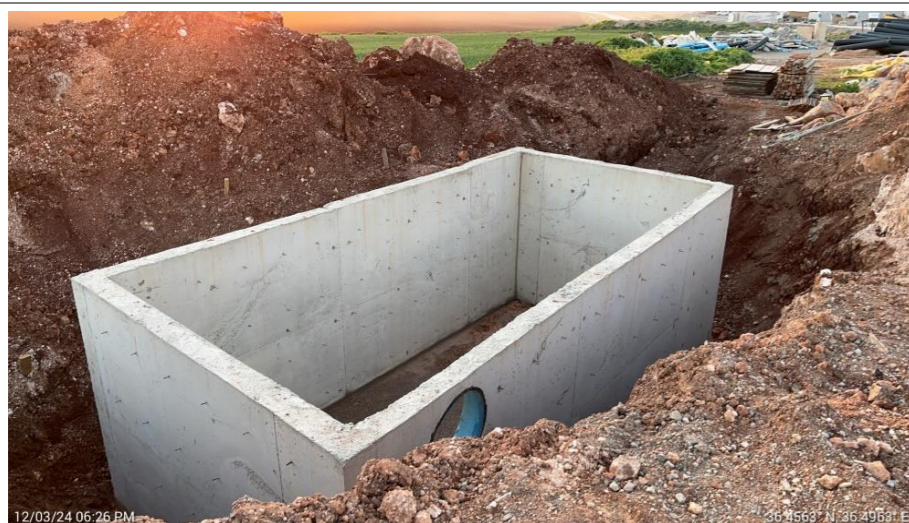
Figure 42. New Septic Tank in the Kizilkaya Construction and Accommodation Site

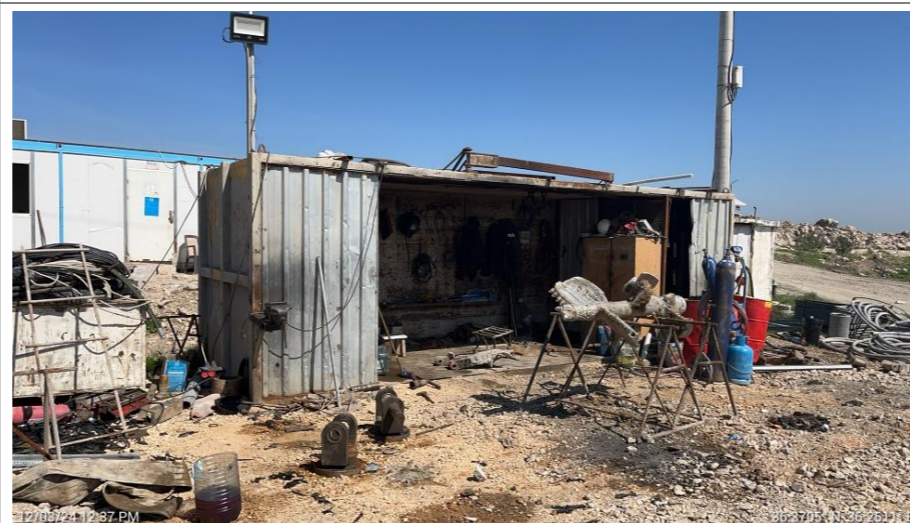
Topic/Issue	Kızilkaya Construction and Accommodation Site	Kızilkaya Quarry	Islahiye-Hassa-Kırıkhan Road Construction Area	Hatay Airport Road Construction Area
Raw Material Supply	Kızilkaya Quarry	N/A	Raw materials have been supplied from Kızilkaya Quarry (owned by KGM), Opal Quarry and Bozkayalar Quarry.	Raw materials have been supplied from Kızilkaya Quarry (owned by KGM), Opal Quarry and Bozkayalar Quarry.
Pollution Prevention & Waste Management				
Hazardous Wastes	Hazardous waste has been stored in the temporary waste storage area. The dispatch of hazardous waste has been carried out through the online platform of Ministry of EUCC, which is Integrated Environmental Information System (EÇBS)/Waste Management Application (MoTAT).	Existing areas on the construction site are being used.	Construction activities have not started yet.	Waste management practices in the deep soil mixing stations were found to be inadequate, considering national legislation and international standards. Wastes have been stored in open areas regardless of their type and hazard class. (see Figure 43 and Figure 44)

Figure 43. Poor Management of Wastes and Chemicals-1 at the Hatay Airport Road

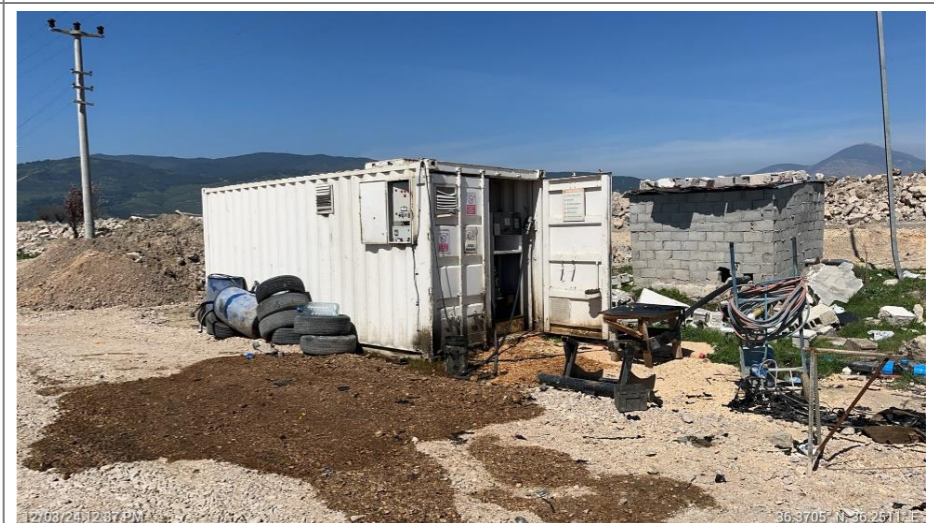
Figure 44. Poor Management of Wastes and Chemicals-2 at the Hatay Airport Road

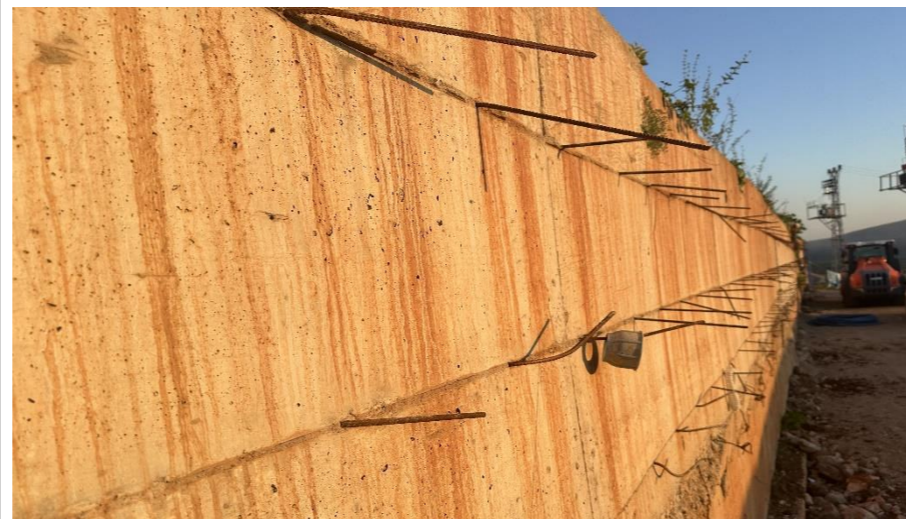
Figure 49. Non-conformity at the Kızılkaya Construction and Accommodation Site-1

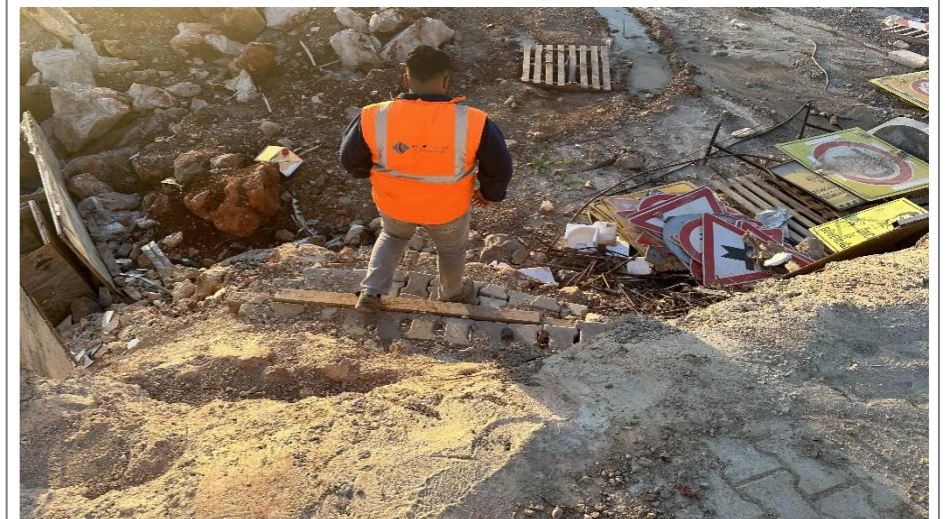
Figure 50. Non-conformity at the Kızılkaya Construction and Accommodation Site-2

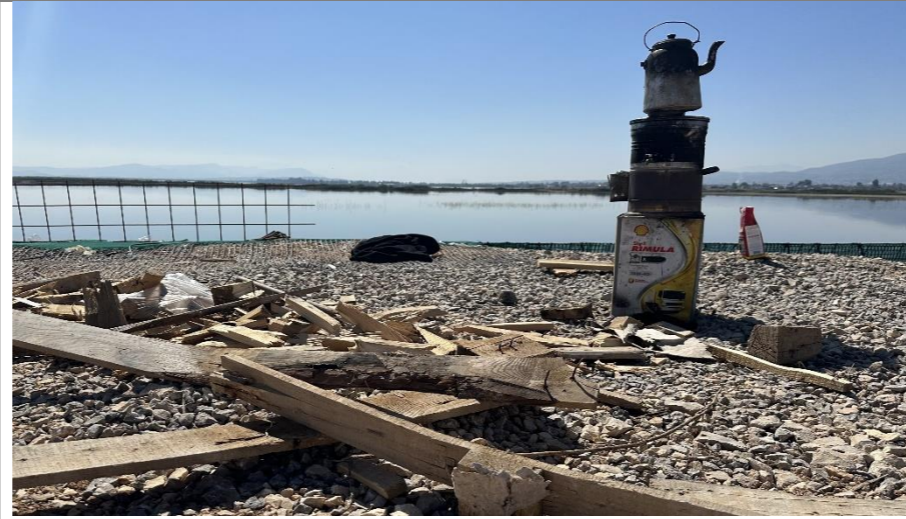
Figure 52. Non-conformity at the Hatay Airport Road Construction Site

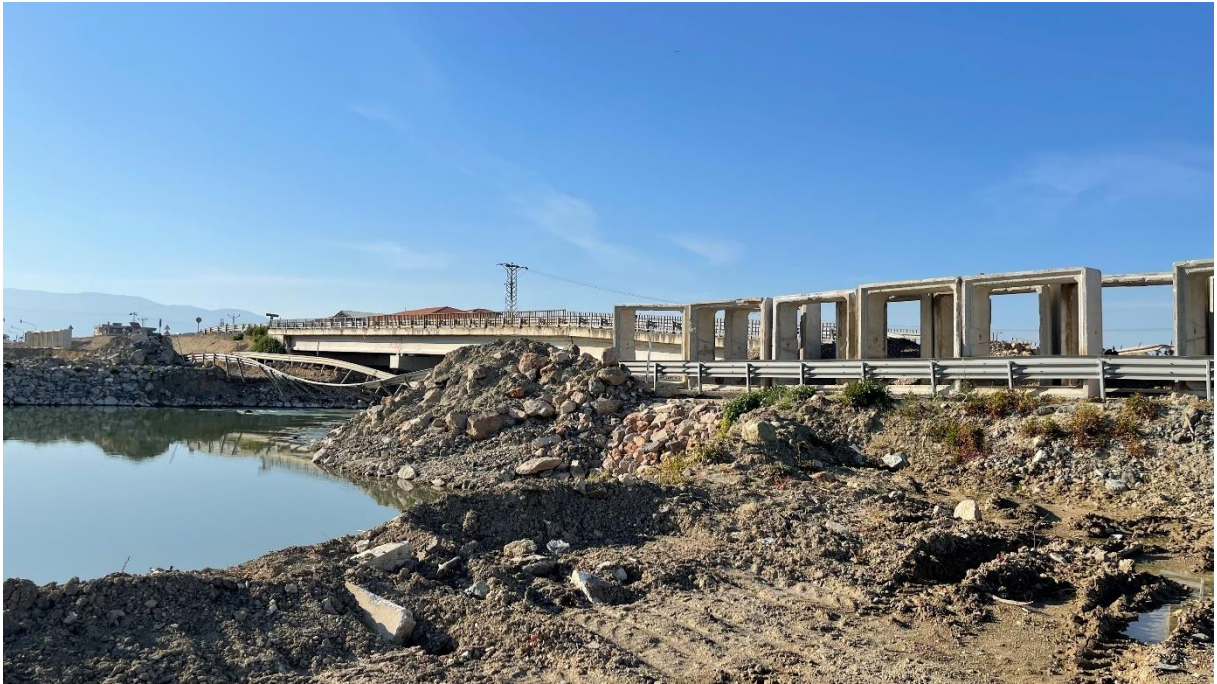
- “Kuruyer Limestone Quarries” and “Kuruyer Construction and Accommodation Site” will be utilized within the scope of the sub-project. Kuruyer Construction site is still under construction. It is anticipated that the use of the construction site will begin in April.
- Kızılkaya Construction and Accommodation Site is currently being used until the Kuruyer Construction and Accommodation Site is completed.
- It was observed during the site visit that Demirköprü Bridge is currently being reconstructed (see Figure 54).
- Road renewal and partial arrangement activities are being carried out in various sections.

Figure 54. Demirköprü Bridge Construction Area

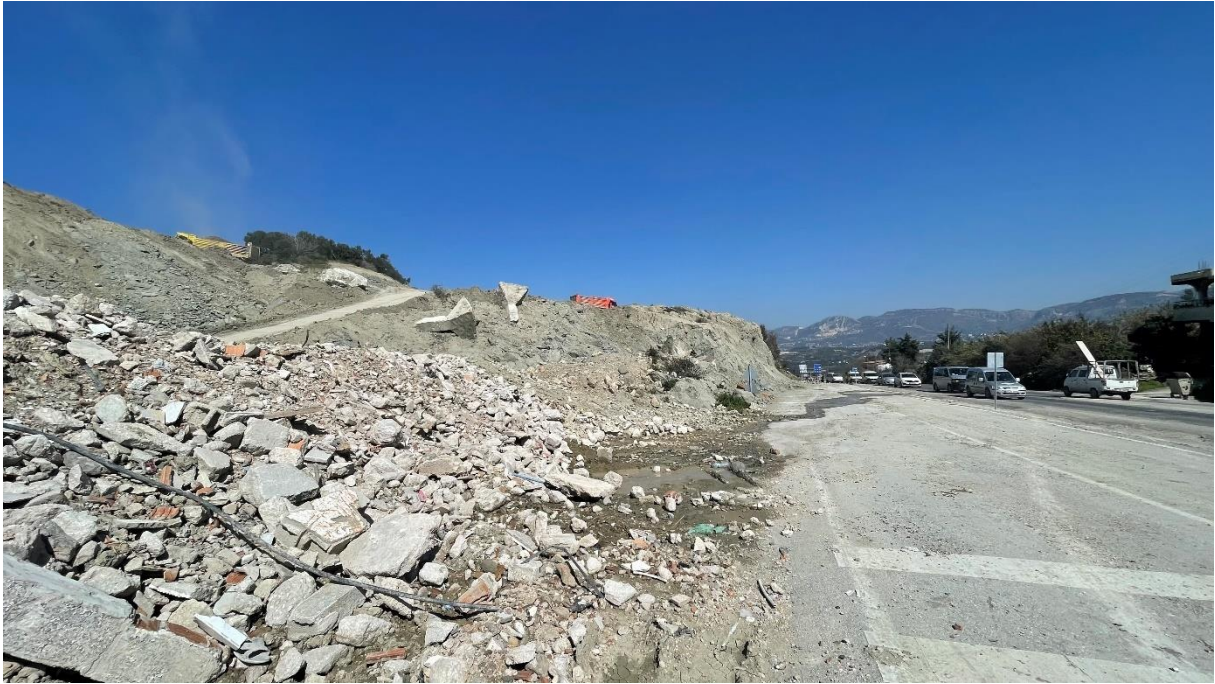
- “Kuruyer Limestone Quarries” and “Kuruyer Construction and Accommodation Site” will be utilized within the scope of the sub-project. Kuruyer Construction site is still under construction. It is anticipated that the use of the construction site will begin in April.
- Kızılkaya Construction and Accommodation Site is currently being used until the Kuruyer Construction and Accommodation Site is completed.
- There is a ready-mixed concrete facility located on the construction area with a capacity of 50 m³/hour for the reconstruction works of Demirköprü Bridge.
- Asphalt renewal works have not commenced yet.
- It was observed during the site visits that the landslide removal works at the 6th km are continuing by the subcontractor (see Figure 58).

Figure 58. Landslide Removal Works at the Project Site

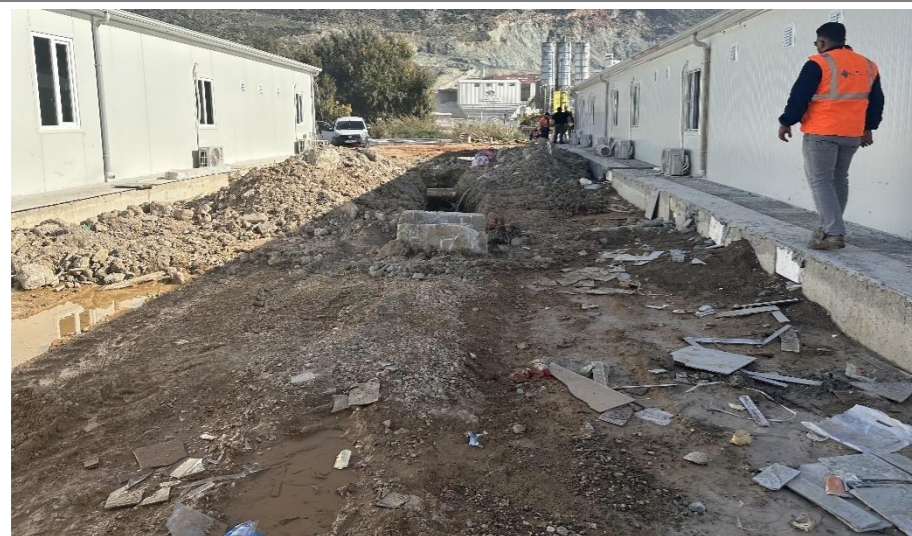
Topic/Issue	Kuruyer Construction and Accommodation Site	Kuruyer Limestone Quarries	Antakya-Reyhanlı Road Construction Area	Antakya-Samandağ Road Construction Area
	<p>It was observed that safety measures were not taken for excavated areas during landscaping (see Figure 66).</p> <p>It has been observed that there are no informational or warning signs in the construction site that is still under installation.</p> <p>It has been observed that the procurement of items to be used for accommodation has been completed (see Figure 67 and Figure 68).</p> <p>The administrative building and dormitory building have been constructed with emphasis on natural lighting, natural ventilation, and thermal comfort (see Figure 69).</p>			
Procurement and Usage of PPE	All employees are provided with work shoes, high visibility jacket, and helmets. Employees working at heights or involved in welding tasks are provided with PPE such as harness lanyard, goggles, earplugs, gloves, etc.	All employees are provided with work shoes, high visibility jacket, and helmets. Employees working at heights or involved in welding tasks are provided with PPE such as harness lanyard, goggles, earplugs, gloves, etc.	All employees are provided with work shoes, high visibility jacket, and helmets. Employees working at heights or involved in welding tasks are provided with PPE such as harness lanyard, goggles, earplugs, gloves, etc.	All employees are provided with work shoes, high visibility jacket, and helmets. Employees working at heights or involved in welding tasks are provided with PPE such as harness lanyard, goggles, earplugs, gloves, etc.

Figure 66. Non-Conformity in Kuruyer Construction and Accommodation Area

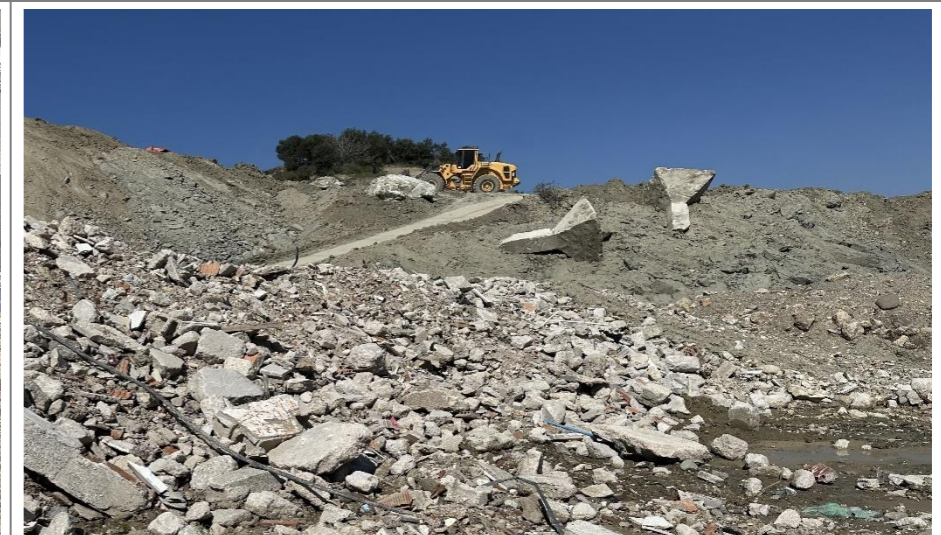
Emergency Drills	The Emergency Drill has not been conducted yet.	The Emergency Drill has not been conducted yet.	The Emergency Drill has not been conducted yet.	The Emergency Drill has not been conducted yet.
Safety of the construction/accommodation area	During the site visit, it was observed that the building constructions at The Kuruyer Construction and Accommodation Site were completed, while landscaping works were still ongoing.	Work has not yet commenced on the Kuruyer Limestone.	At the Antakya-Reyhanlı Road Construction Site, warning signs and safety barrier around excavation areas are insufficient (see Figure 70).	Construction machinery was working in the landslide area on the Antakya-Samandağ road (see Figure 71).

Figure 71. Landslide Area on the Antakya-Samandağ Road.

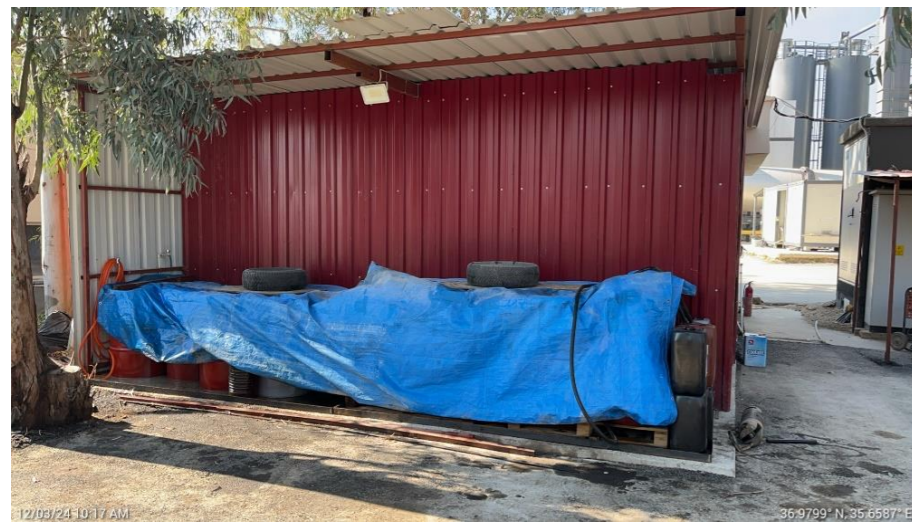
Chemical Management	<p>There is chemical use and storage in the facility The drip tray is available (see Figure 87).</p> <p>The facility has been evaluated as out of scope according to BEKRA Regulation.</p>	It was observed during the field visit that there was no chemical storage.	It was stated that chemicals have not been stored.	No information is available	There was no chemical storage on the site. Fuel supply has been done by mobile vehicles.
Soil Contamination Risk	There is a secondary containment structure for the diesel tank. However, for other storage tanks, anti-leakage measures should be taken to prevent soil contamination (see Figure 88 and Figure 89).	No soil contamination was observed during the site visit.	No information is available	Material extraction works have not started yet.	It was observed that the soil in the activity area of Başpınar Viaduct was contaminated due to leakage of cement-based building component (grout material). Chemical substance management must be carried out effectively and secondary containment structures must be used (see Figure 90)

Figure 87. Chemical Storage Area in Ceyhan Construction and Accommodation Site

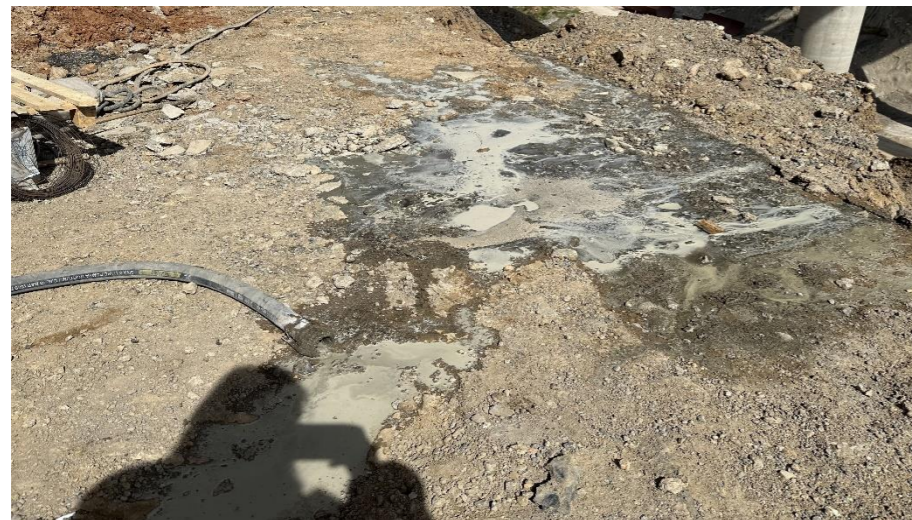
Figure 90. Soil Contamination in the activity area of Başpınar Viaduct

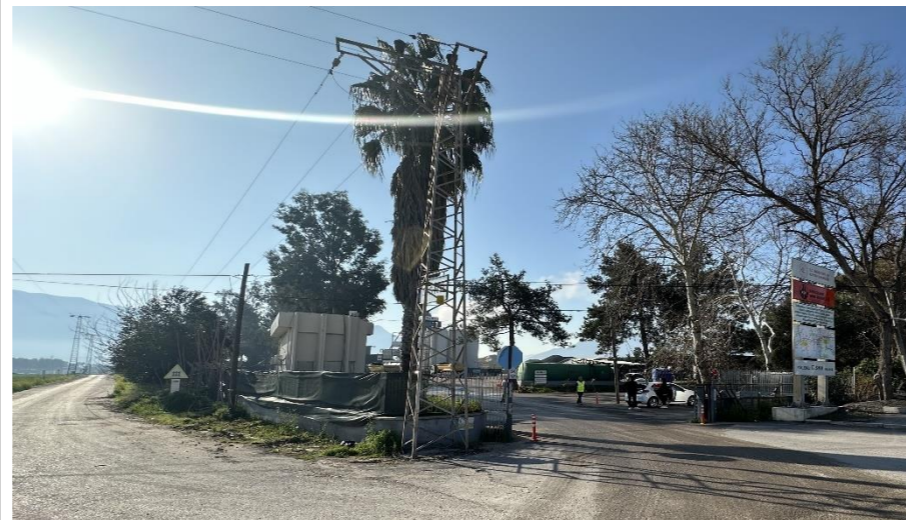
Community Health and Safety					
Security	The facility area was surrounded by fences. There is a security cabin at the entrance (see Figure 91).	The facility area has not been surrounded by fences.	The quarry has not been surrounded by fences.	The quarry has not been surrounded by fences.	It was observed that the roads were closed to transportation in the areas where the activity was carried out.
Information and Warning/Safety Signs	Information and warning signs are also available (see Figure 92).	The number of the warning/safety signs should be increased.	No information is available	Material extraction works have not started yet.	The number of the warning/safety signs should be increased.
Occupational Health and Safety					
OHS Documents	<p>The Risk Analysis Report was prepared by the contractor company SNH in May 2023</p> <p>The Emergency Response Preparedness Plan was prepared by the contractor company SNH in May 2023</p> <p>Within the scope of annual plans and reports, "Annual Training Plan, Annual Work Plan, and Annual Evaluation Report" have been prepared in January 2024.</p>	<p>The Risk Analysis Report was prepared by the contractor company in March 2024</p> <p>The Emergency Response Preparedness Plan was prepared by the contractor company SNH in March 2024</p> <p>Within the scope of annual plans and reports, "Annual Training Plan, Annual Work Plan, and Annual Evaluation Report" have been prepared in March 2024</p>	<p>The Risk Analysis Report was prepared by the contractor company SNH in May 2023</p> <p>The Emergency Response Preparedness Plan was prepared by the contractor company SNH in May 2023</p> <p>Within the scope of annual plans and reports, "Annual Training Plan, Annual Work Plan, and Annual Evaluation Report" have been prepared in January 2024.</p>	<p>Material extraction works have not started yet.</p>	<p>The Risk Analysis Report was prepared by the contractor company SNH in June 2023</p> <p>The Health and Safety Plan was prepared by the contractor company SNH in July 2023</p> <p>The Emergency Response Preparedness Plan was prepared by the contractor company SNH in June 2023</p> <p>Within the scope of annual plans and reports, "Annual Training Plan, Annual Work Plan, and Annual Evaluation Report" have been prepared.</p>

Figure 91. Entrance of Ceyhan Construction and Accommodation Site

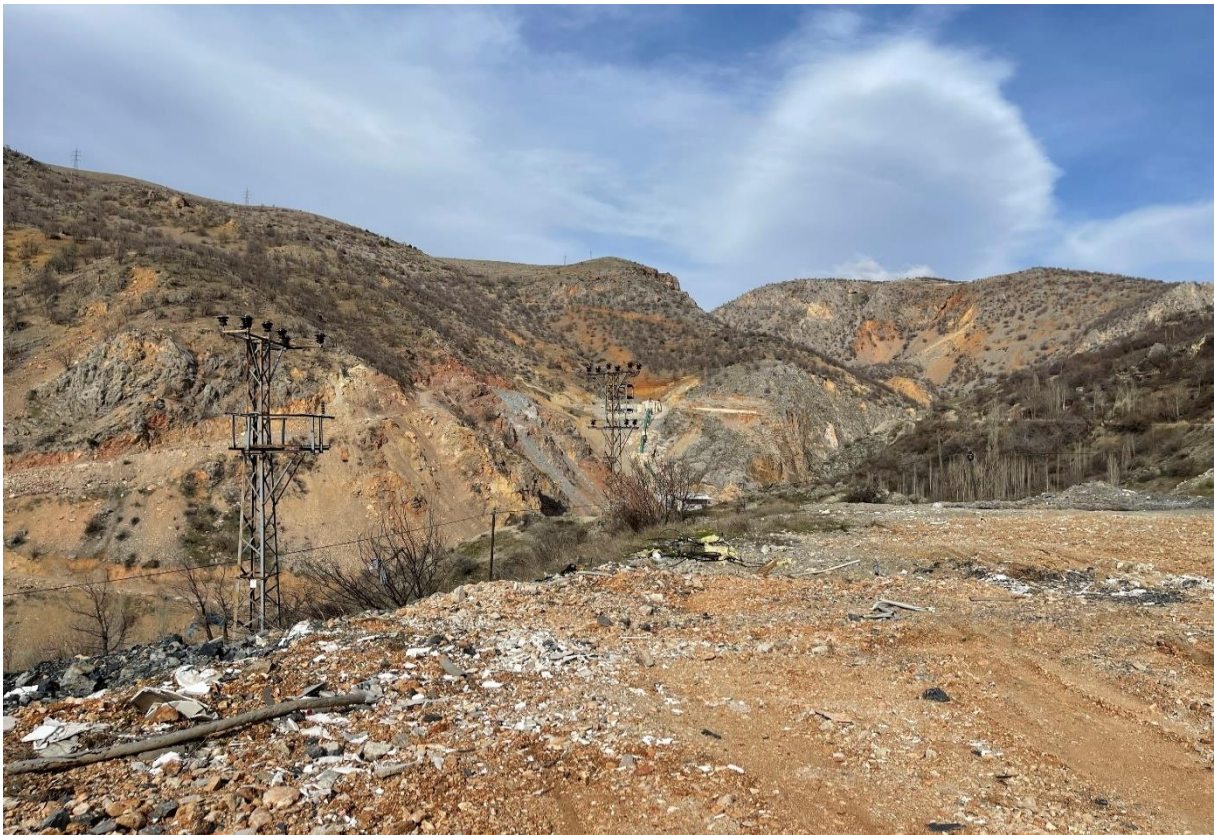
- It was stated by 8th Regional Directorate of Highways that the damages on the road were temporarily repaired after the earthquake.

Figure 97. Damage on the Road – 2

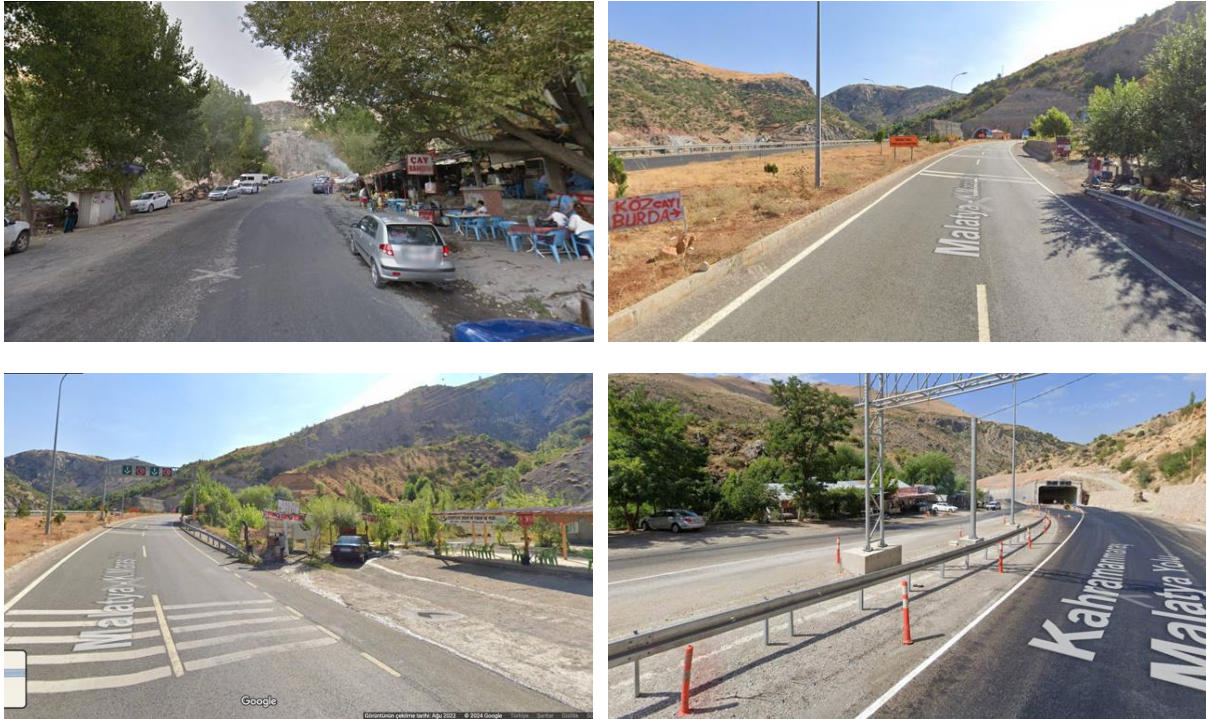
The surroundings of Erkenek Tunnel are businesses, recreation facilities selling food and beverages, and areas where passengers stop for short periods of time.

Figure 101. Businesses around Erkenek Tunnel

In order for these businesses not to lose customers during construction works and to continue their business safely, mitigation measures to prevent loss of livelihood should be planned in consultation with the businesses.

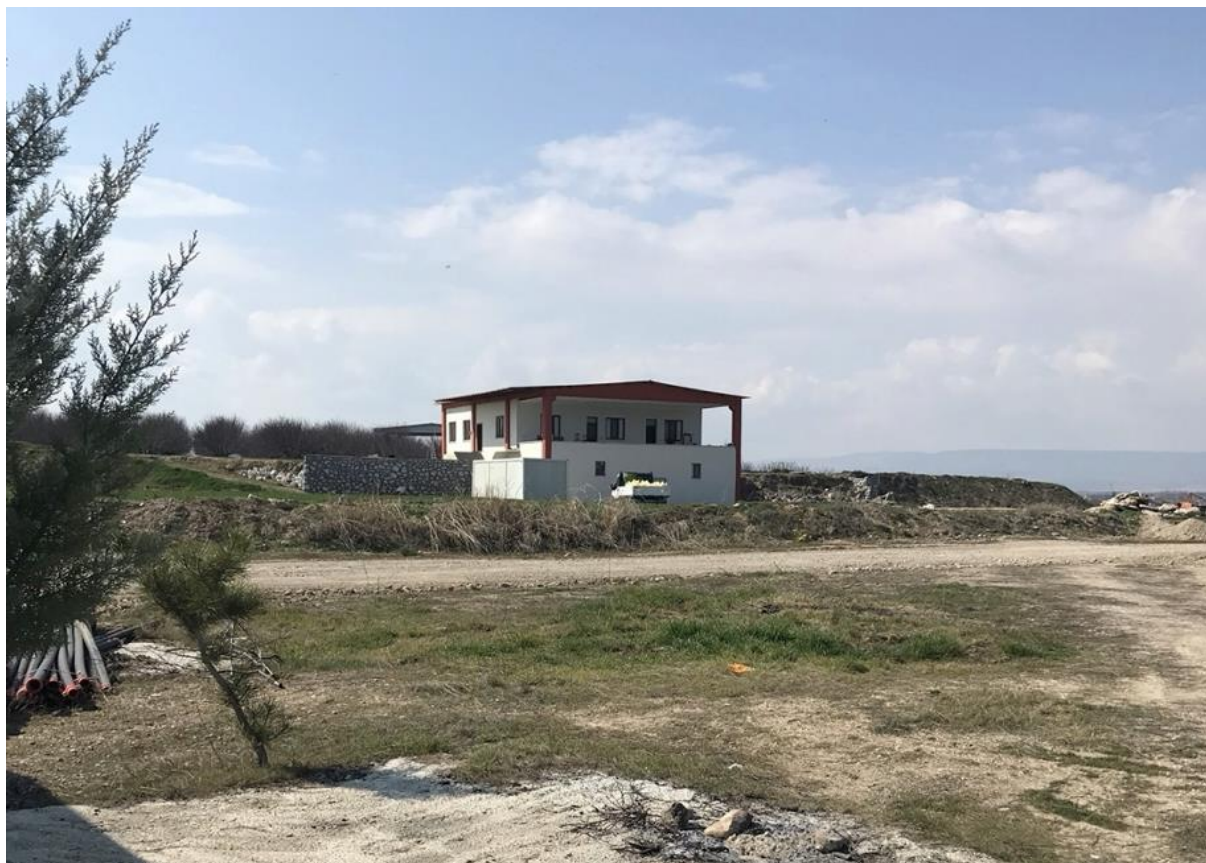
Tohma Camp Site is installing on a land which includes a private 2-storey house structure belonging to the owner of the construction site parcel.

Figure 108. 2-storey house structure in the Tohma Camp Site Parcel

Since the land owner's previous house was destroyed in the earthquake, he had a house built on this empty parcel of his own after the earthquake and he still lives in this area. The landowner rented the land to the Project by consent in return for an agreement and was not subject to any loss of rights or forced physical resettlement.

The land owner of the Tohma Construction Site continues his livestock farming activities on the land and its surroundings. Although there is no physical forced resettlement in this context, project impacts that may have a negative impact on livelihoods should be monitored, and compensation should be provided if necessary to prevent loss of livelihood by consulting with PAPs.

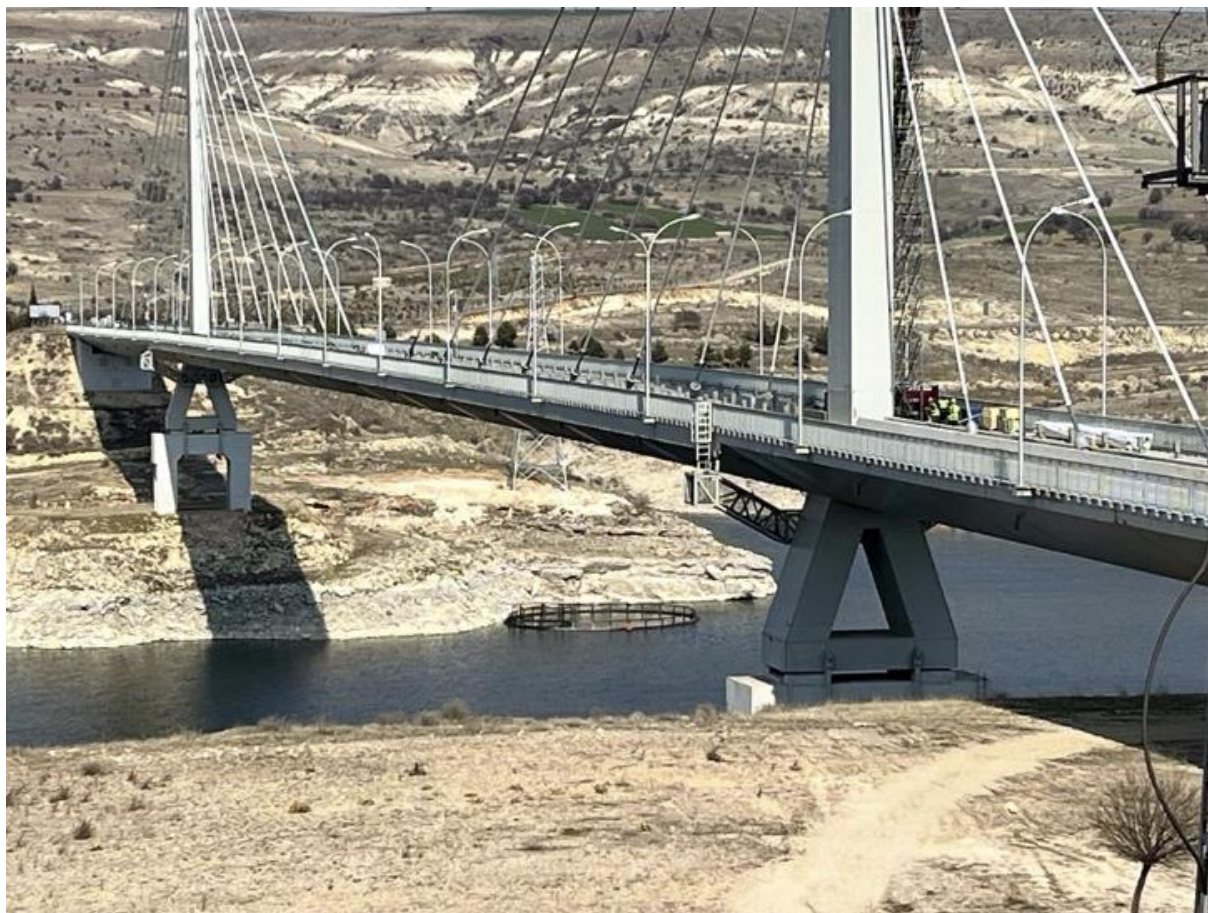
A private company has fishing activities under the Ađın Bridge as shown in the figure below.

Figure 109. Fishing Activity under the Ağın Bridge

Even though Project Works have a content that will not affect the fishing activity and fishing area, the PAPs carrying out the fishing and the business will be interviewed within the scope of the Project's Livelihood Restoration Plan (LRP) and ecosystem services impact assessment under the ESIA.

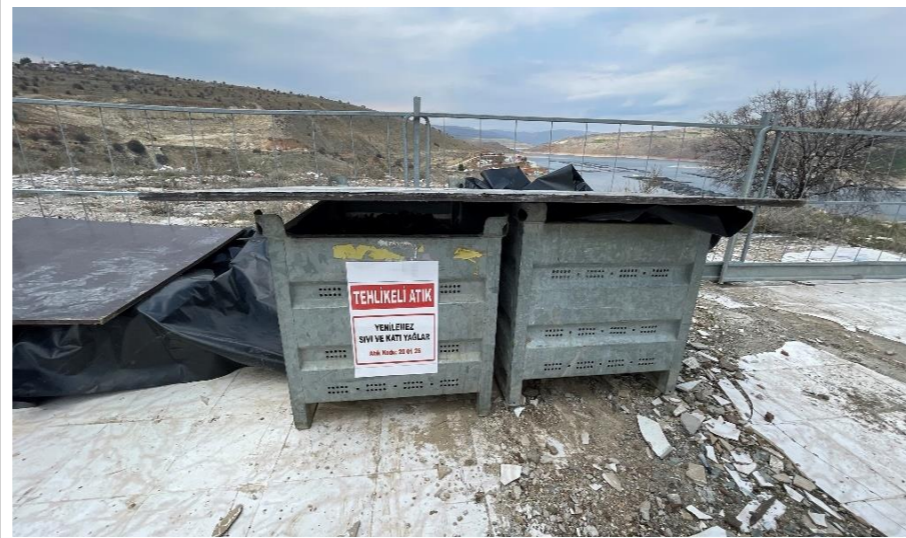
Wastewater management	The work has not started yet.	There is a septic tank belongs to the landowner near the construction site.	Wastewater infrastructure has not existed yet, a septic system will be installed.
Raw Material Supply	It will be procured through purchases from abroad.	It will be procured through purchases from abroad.	It will be procured through purchases from abroad.
Pollution Prevention & Waste Management			
Hazardous Wastes	The work has not started yet.	No information has been shared.	No agreement has been made yet regarding waste disposal facilities.
Non-Hazardous Wastes	The work has not started yet.	Domestic wastes have been collected by the municipality.	Domestic wastes have been collected by the Ağın Municipality (see Figure 110).
Temporary Waste Storage Area	The work has not started yet.	The work has not started yet. The site is under construction.	A temporary waste storage area in compliance with national legislation has not yet been constructed. The container and waste code are available for a specific waste (see Figure 111). A spill kit is available on site (see Figure 112).

Figure 111. Hazardous Waste Containers in the Ağın Construction Site

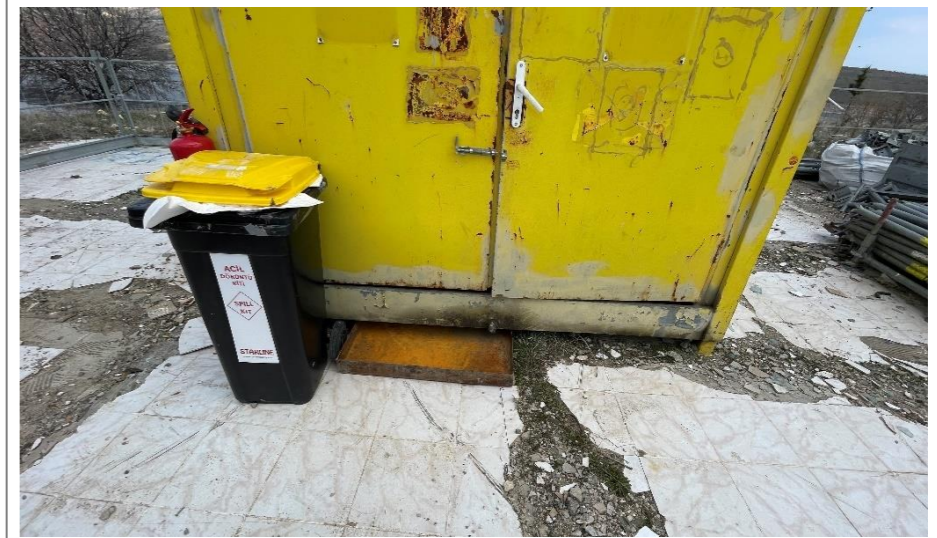
Figure 112. Spill Kit in the Ağın Construction Site
