TÜRKİYE EMERGENCY ROAD REHABILITATION AND RECONSTRUCTION PROJECT

ENVIRONMENTAL AND SOCIAL DUE DILIGENCE REPORT

CNR-KGM-TERRRP-ESDD-001

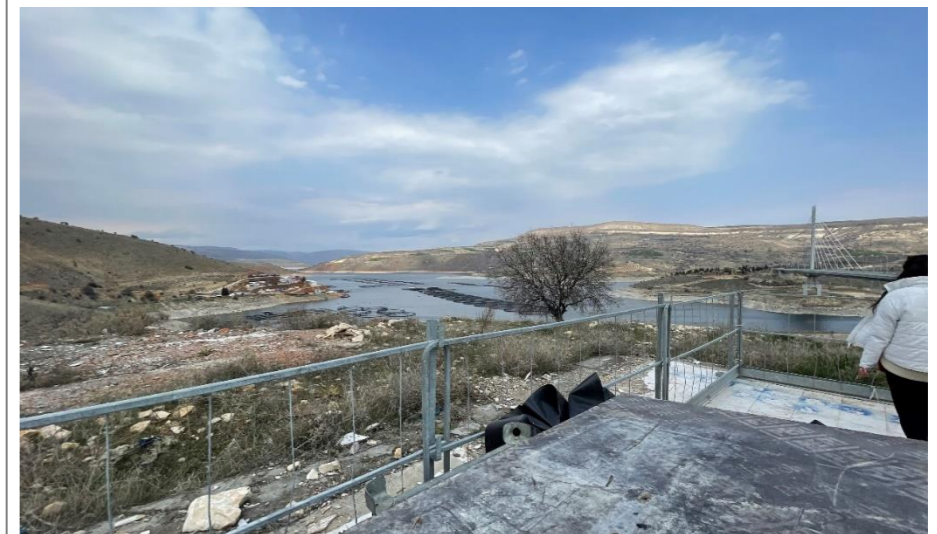
Community Health and Safety			
Fencing of the facility area Security cabin	The work has not started yet.	This construction and accommodation site is still under construction.	The construction site area has been partially fenced (see Figure 115), there is no security cabin available, and a guard is on duty at night.
Information and Warning/Safety Signs	The work has not started yet.	This construction and accommodation site is still under construction.	It is recommended to increase the number of warning signs and signs.
Occupational Health and Safety			
OHS Documents	The work has not started yet.	There is no Risk Analysis Report to be prepared for the accommodation area. There is no Risk Analysis Report to be prepared for the accommodation area.	Occupational Health and Safety Professional Contracts are available. The Risk Analysis Report was prepared by the contractor company ENKON on 22.02.2024. The Health and Safety Plan was prepared by the contractor company ENKON in February.2024. The Emergency Response Preparedness Plan was prepared by the contractor company ENKON on 22.02.2024. Within the scope of annual plans and reports, "Annual Training Plan, Annual Work Plan, and Annual Evaluation Report" have been prepared. OHS trainings have been provided and records have been maintained.

Figure 115. Surrounding of the Ağın Construction Site

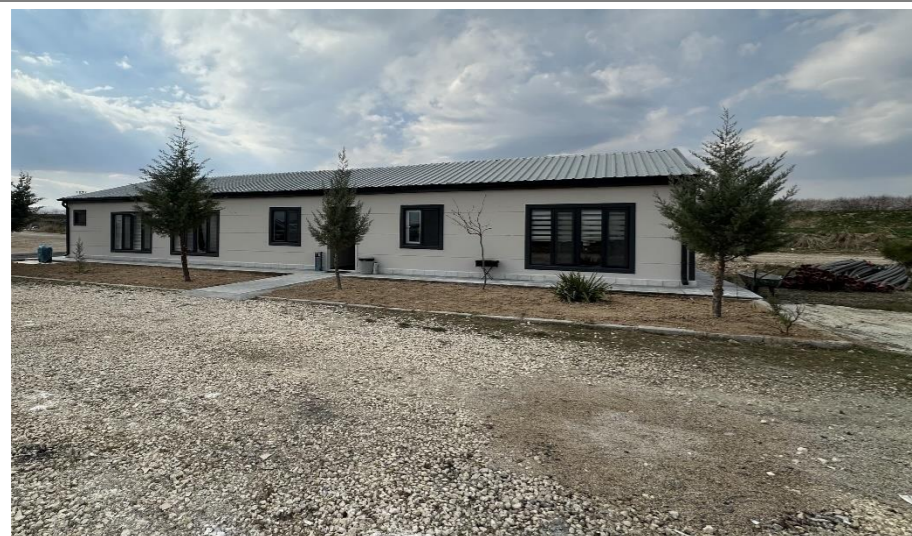
Emergency Drills	The work has not started yet.	The work has not started yet.	The Emergency Drill has not been conducted yet.
Safety of the construction/accommodation area	The work has not started yet.	Work has not started yet. There is no construction site; only accommodation site is available (see Figure 116) Ergonomics, thermal comfort, natural ventilation, and natural lighting have been prioritized in office and accommodation areas (see Figure 117). Wire insect screens are available to protect against flying insects.	The scaffold has been set up for the repair work on the Ağın Bridge (see Figure 118). Traffic is restricted under controlled conditions.
Procurement and Usage of PPE	The work has not started yet.	The work has not started yet.	All employees are provided with work shoes, work clothes, gloves, masks, goggles, and helmets. Additionally, the maintenance team has been provided with harness lanyard.

Figure 116. Tohma Accommodation Site
